URGENT Field Safety Notice

Multiva 1.5T

Potential for System Shutdown and Magnet Bore Cover Thermostability Issue

January 13, 2025

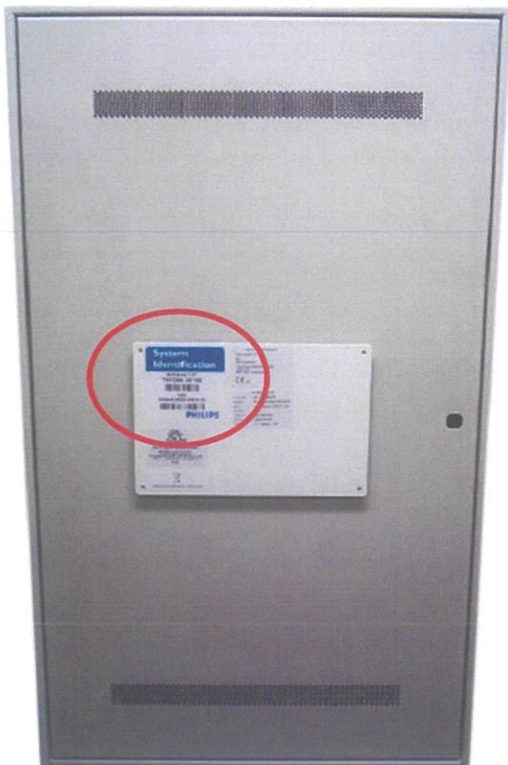
Figure 2: Front door of gMDU

- 3.1. Enter the Technical Room
- 3.2. Locate the general Mains Distribution Unit (gMDU) and Liquid cooling cabinet (LCC)
- 3.3. The system label is located on the front door of the gMDU (see figure 2) or LCC (see figure 3)
- 3.4. Locate the serial number on the system identification label (see figure 4)
