Urgent Field Safety Notice

Reference Number: 1170852 Vasoview Hemopro 2 Endoscopic Vessel Harvesting System (VH-4000 and VH-4001)

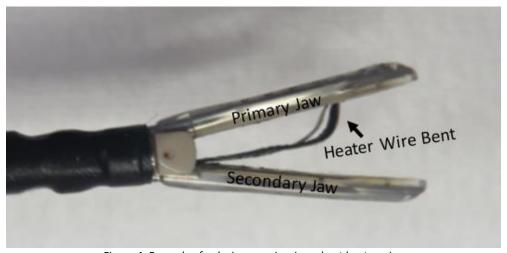
A detached heater wire is defined by disconnection of the heater wire tip from the silicone on the distal end of the harvesting tool jaw, with the proximal end of the heater wire remaining attached to the proximal end of the jaw. It is important to note the heater wire is still attached to the harvesting tool. A bent heater wire is defined by the heater wire bending away from the jaw with no detachment of the distal end. The heater wire can become bent or detached from external mechanical forces or during the initial phase of jaw degradation from user-activated over-delivery of energy. Thermal degradation refers to the process in which the jaw silicone material breaks down or loses its desirable properties due to exposure to high temperatures. This degradation occurs when the heat causes chemical bonds within the silicone polymer to weaken or break, leading to a reduction in the material's structural integrity and flexibility making it more brittle and prone to cracking or tearing.

Figure 4: Example of a device experiencing a bent heater wire.

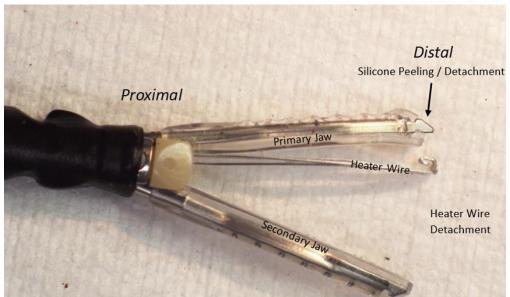
Figure 55: Example of a device experiencing both Heater Wire Detachment and Silicone Peeling/Detachment.

Peeling or detachment of silicone from the Hemopro 2 Harvesting Tool Jaws can result in the Harvesting Tool not functioning as designed and intended. If the Hemopro 2 Harvesting Tool Jaw Heater Wire becomes compromised, bent, or detached from the Jaw during use (as referenced in Figure 5), there is risk of creating hazardous situations that may result in patient harm. The following patient harms, listed in the order of most to least likely to occur, may result if either of the device failures occurs during use of the Vasoview Hemopro 2 EVH System:

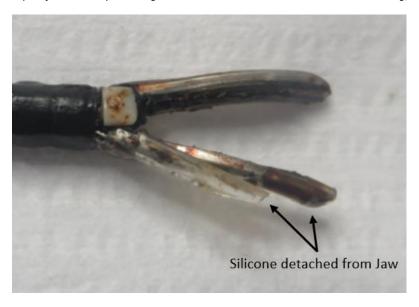
Silicone peeling is defined as silicone that has peeled away from the Harvesting Tool Jaw but remains attached to the Jaw. Silicone detachment is defined as silicone that has peeled away from the Harvesting Tool Jaw(s) and detached from the Jaw assembly. Silicone peeling and detachment can occur when thermal loads on the device are not allowed to adequately cool down between actuations. This can happen when the device is actuated for long periods of time or in quick succession, such as in repeated tissue dissection or application of energy without tissue between the jaws.

Figure 6: Example of a device experiencing silicone detachment.
