Updated URGENT Field Safety Notice

IntelliSpace Cardiovascular

Report content may be inaccurate when using Finding Codes to add information

05-SEP-2025

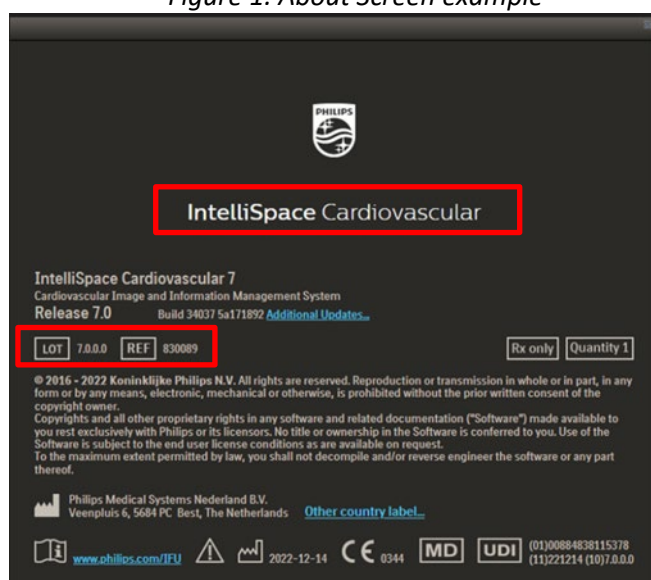
Figure 1. About Screen example

Impacted products are listed in Table 1 and can be identified by the product name, reference number, and lot number (represents the software version) which are located on the About Screen as shown in Figure 1.
