## Field Safety Notice

MR systems with SW versions R11.1 and R12.1  
MobiView cross reference alignment errors

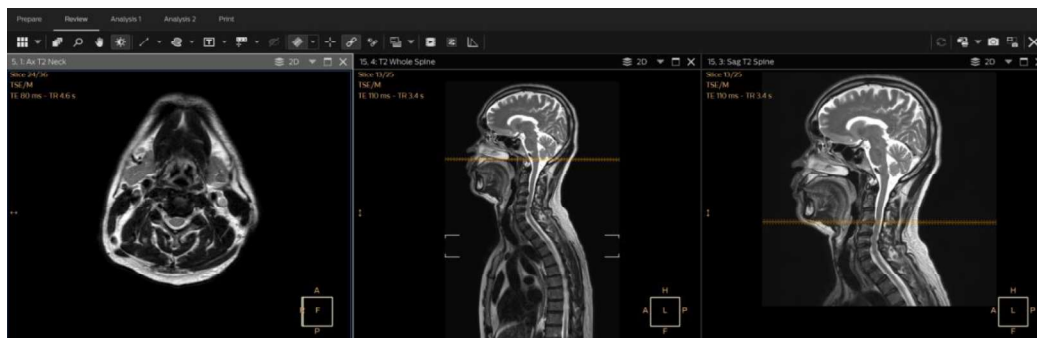
- A. The cross reference line and/or box may be shown at an incorrect location when displayed on a MobiView generated image (see examples in Figure 1 and 2).

- Multi-station scans that require stitching 3 or more station images, and
- Scan protocol is used where stations have different voxel size or field of view (i.e. voxel size or field of view is customized based on anatomy per station).

Figure 1. Cross reference line of the axial image (left) is at the incorrect location on the MobiView generated image (middle). The correct location is shown on the non-fused sagittal source image (right).

There is a potential for misdiagnosis if the cross reference information from MobiView generated images is shown at an incorrect location.

- You may continue to use your system(s) in accordance with the intended use.
  - A. To avoid the potential issue of an incorrect cross reference line in MobiView generated images, use the same voxel size and field of view across all station scans.

A Philips representative will contact you to schedule time for a Field Service Engineer (FSE) to install a software upgrade to resolve the issues (reference FCO78100566, FCO78100584, FCO78100585, FCO78100620, FCO78100621).

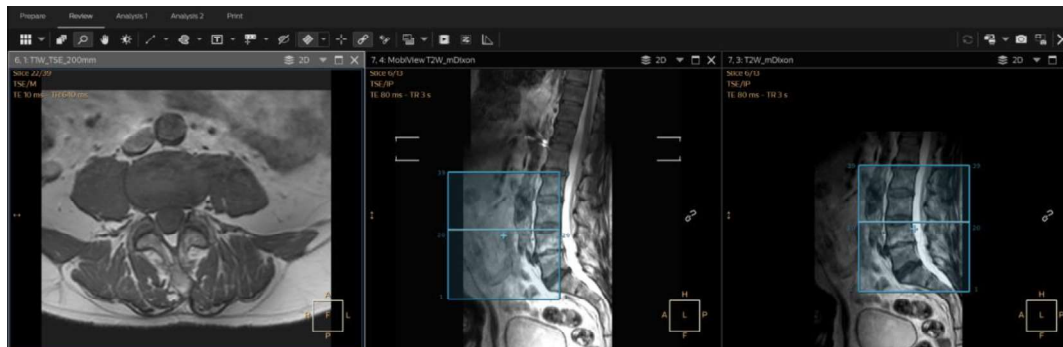
Figure 2. Cross reference box of the axial image (left) is at the incorrect location on the MobiView generated image (middle). The slice position in the box is correct, while the box off-center is incorrect. The correct location is shown on the non-fused sagittal source image (right).

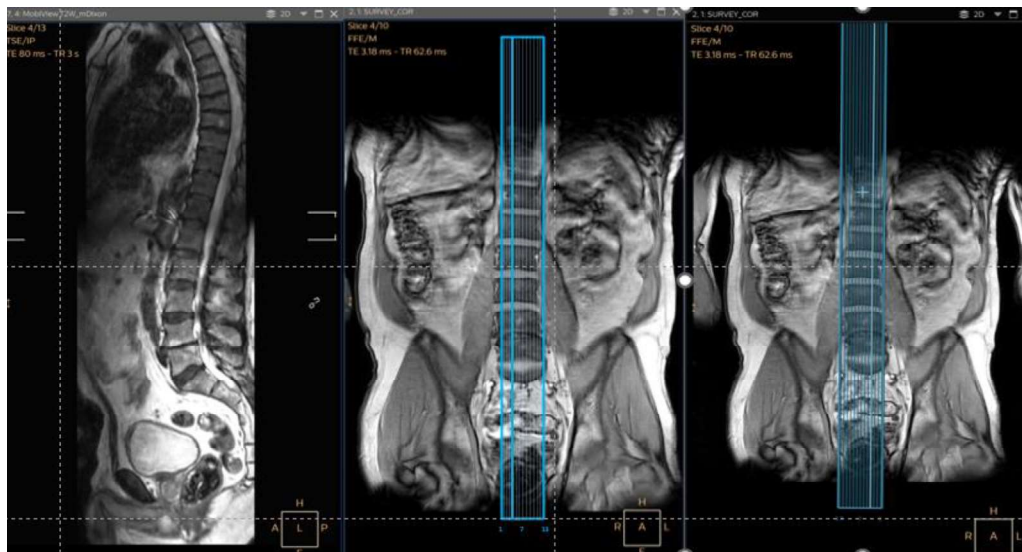
- B. The cross reference box of a MobiView generated image may be shown at an incorrect location when mirrored on to another image (see examples in Figures 3 and 4), if:
- the MobiView images are acquired with reversed slice scan order (i.e. image display settings are customized), or
  - displaying the cross reference box of a MobiView generated merged series (axial stations), or
  - displaying the cross reference box of multi-planar reformats generated from multi-stack data.

Figure 3. Cross reference box of a MobiView generated image with reversed slice scan order (left) is mirrored on another image (middle). The box position is correct, while the slice position and slice numbering are incorrect. The correct location is shown for a MobiView generated image with default slice scan order (right).

- B. Do not use cross reference line functionality in box mode, all slices mode, or 3D mode. Use the cross reference line functionality in single slice mode.

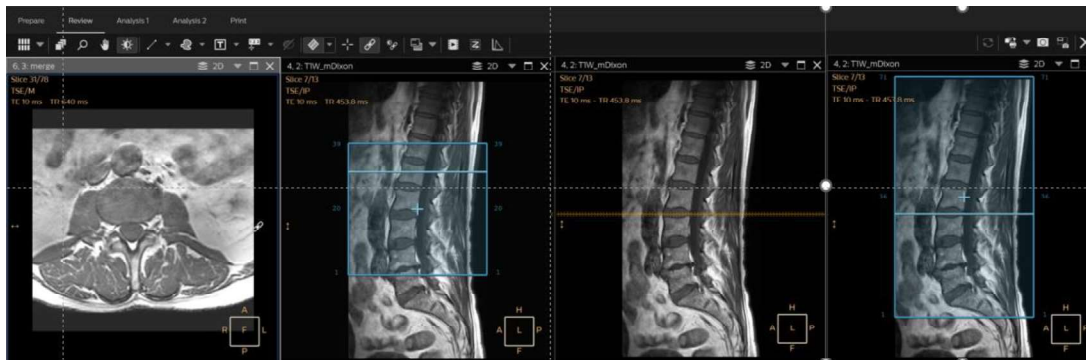
Figure 4. Cross-reference box of a MobiView generated axial merged series (left) displays with incorrect size and location on another scan (mid-left). The cross-reference line of the same MobiView generated axial merged series is at the correct location (mid-right). The correct box size and location is shown for a Mobiview generated axial fused series (right).
