FSN Ref: 2025-FSN-000103

URGENT Field Safety Notice
Risk of Automated Impella Controller (AIC) Intermittent Impella
Detection Issue.

1. Information on Affected Devices*	
1.	1. Device Type(s)*
	All Automated Impella Controller (AIC)
1.	2. Commercial name(s)*
	Automated Impella Controller (AIC)

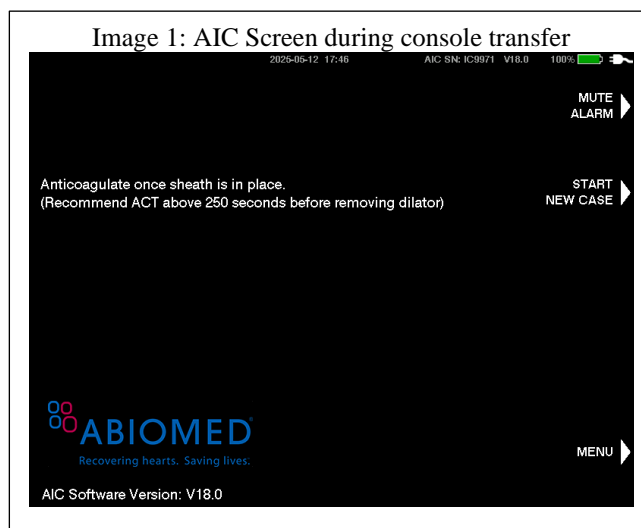
During console-to-console transfer, if the pump is not detected once connected to the AIC, the AIC screen in Image 1 remains and does not advance.

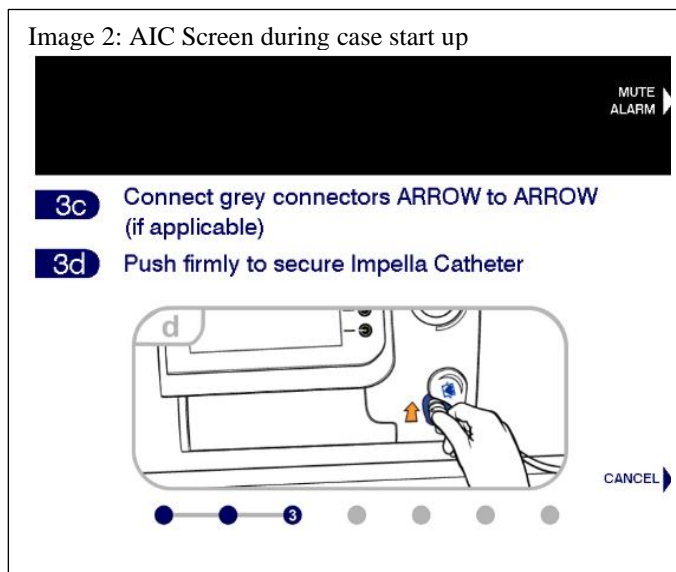
During case start, if the pump is not detected once connected to the AIC, the AIC screen in Image 2 remains and does not advance.

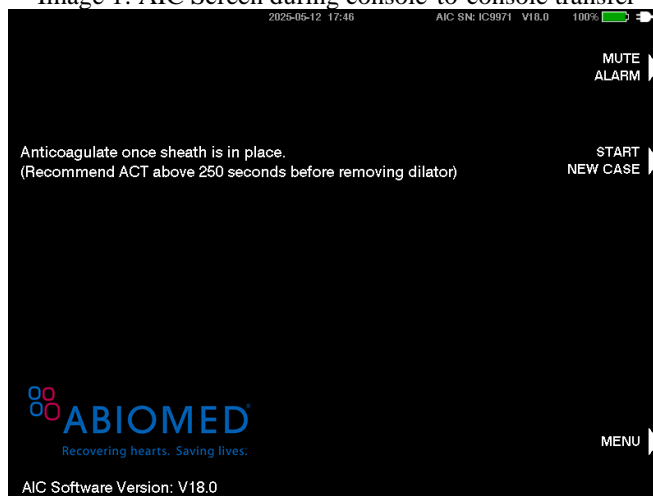
Image 1: AIC Screen during console-to-console transfer

The AIC screen in Image 1 remains for more than 20 seconds and does not advance after connecting the pump to the receiving console:

- Scenario 1: If no alarm on the previous console, then immediately switch the pump to the previous console to restore support to the patient.
- Scenario 2: If the previous console displays an alarm message, then switch to a different console if available. If a different console is not available proceed to scenario 3.
- Scenario 3: If the previous console displays an alarm message, but a different console is not available, then re-start the case on the receiving console (console that does not advance from Image 1 before attempting to re-connect a pump):
 1. unplug the pump
 2. re-start the console
 3. press START NEW CASE from the startup screen

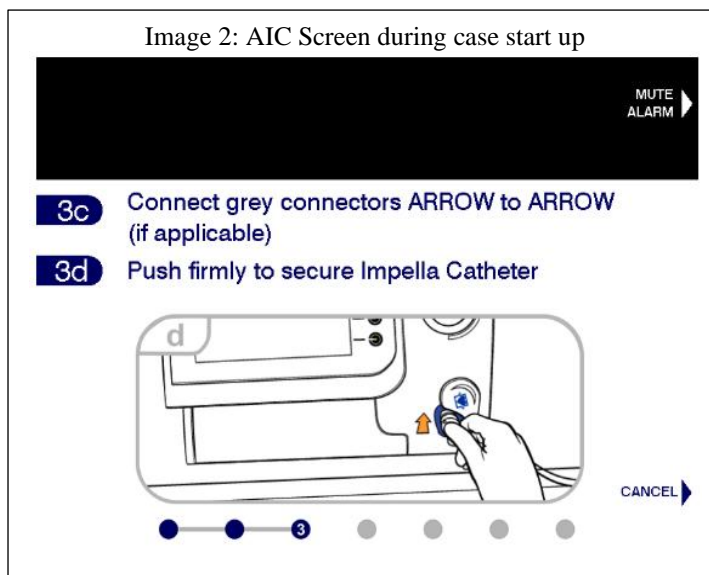
The AIC screen in Image 2 remains for more than 20 seconds after connecting the pump and does not progress to indicate “Detecting Impella”:

- Option 1: re-start the case:
 - unplug the pump
 - re-start the console
 - press START NEW CASE from the startup screen
- Option 2: switch the pump to a different console if available.
