URGENT Field Safety Notice

Philips Azurion Systems R1.x and R2.x

Software issue potentially resulting in loss of imaging (X-ray) functionality

04-JUN-2025

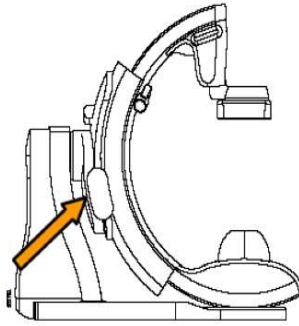
Figure 1- System Identification Label

The System Product Name and Model Number can be found on the System Identification Label located on the System stand (Figure 1). The software version of the Philips Azurion systems can be identified during start-up (Figure 2).
