FSN Ref: 2025-FSN-000103

FSCA Ref: 2025-FA-000103

Date: 2025-06-24

URGENT Field Safety Notice
Risk of Automated Impella Controller (AIC) not detecting an Impella pump when it is connected.

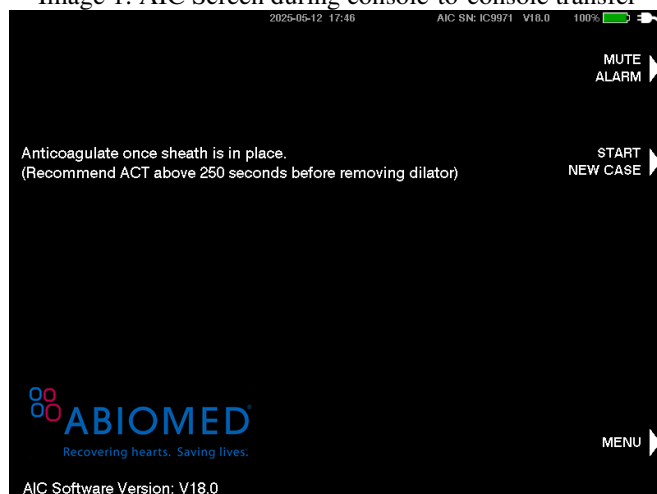
Image 1: AIC Screen during console-to-console transfer

If the AIC screen in Image 1 remains for more than 20 seconds and does not advance after connecting the pump to the transferred console:

- Immediately switch the pump to the previous console to restore support to the patient.
- If the previous console displays an alarm message, switch to a different console if available.
- Restart the console that does not advance from Image 1 before attempting to re-connect a pump.
