Date: 27-Jun-2025

Urgent Field Safety Notice
3mensio Workstation (Vascular – Fenestrated)
Version (10.6, 10.6 SP1, 10.6 SP2, 10.6 SP3, 10.6 SP4, 10.7, 10.7 SP1)

The purpose of this letter is to advise you that Pie Medical Imaging is issuing an urgent Field Safety Notice regarding the clock position visualization in the fenestration diagram in 3mensio Workstation 10.6 (Vascular – Fenestrated layout) or 3mensio Workstation 10.7 (Vascular – Fenestrated layout).

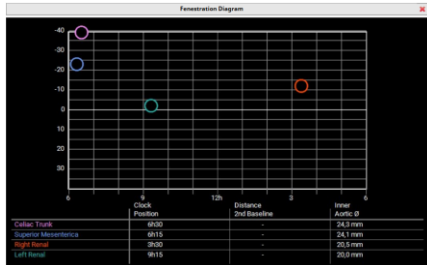
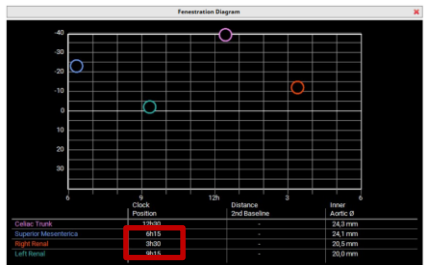
Observed behaviour: In the fenestration diagram only the adjusted clock measurement is updated to the new 12h position. The other clock measurements are not updated relative to the new 12h position

Opening a fenestrated analysis with clock measurements	Changing 12h position of a single clock measurement → Only the adjusted clock measurements is updated in the fenestration diagram.

Impact: The hazard exists that the clock positions are not correct in the report causing fenestrations on a stent graft at an incorrect position. This could potentially be harmful for the patient since this could potentially lead to permanent tissue damage. If FSN advice is followed there is no residual risk.

In case you open a session state with saved clock measurements created in **3mensio Workstation 10.6** and there is a need to adjust the **12h position** for the clock positions, make sure to update **all** individual clock measurements in the perpendicular plane by the following steps:

1. Click on the clock position.
2. Update the 12h pointer of the clock in the perpendicular viewport.
3. Perform step 1 & 2 for all clock measurements in the analysis.
