## Field Safety Notice

### Philips MR Systems

Gradient Coil component failures may act as a heat source with potential to produce smoke and/or fire.

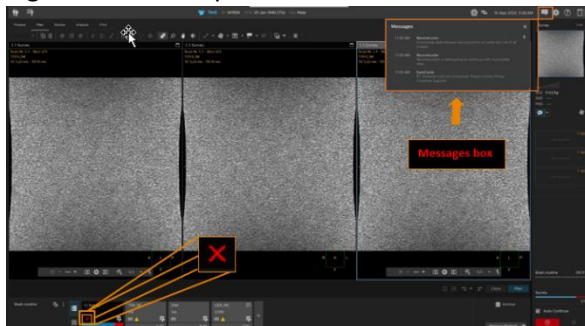
Figure 5. UI example SW Version R11.

- 4.3. When scan aborts occur the symbol is shown and applicable messages are presented in the message box (see Figure 5 and Figure 6 examples)
  - 4.3.1. Check the status of the error messages in the User Interface (UI) screen. Click to expand the message box in case previous messages are hidden, see orange box in Figure 5 and Figure 6 below. If possible, correct the issue that is relevant to the error shown and continue scanning, for example:
    - "RF door must be closed while performing scan. Scan aborted."

- “Patient support is moved while scanning, scan stopped.”
- “Coil A (or B) failure, coil disconnected?”.

- 4.3.2. If, after a scan abort, one of the following conditions occur five times in a row stop scanning immediately and contact Philips Service to describe the problem:

- If there is no error message in the message box
  - If the error message meaning is not clear
- 4.3.3. If the error message “Gradient amplifier Rack Fault” is received two times in a row, or if the error message “Gradient amplifier Rack Fault” is preceded or followed by an aborted scan with no message, then stop scanning immediately and contact Philips Service to describe the problem.

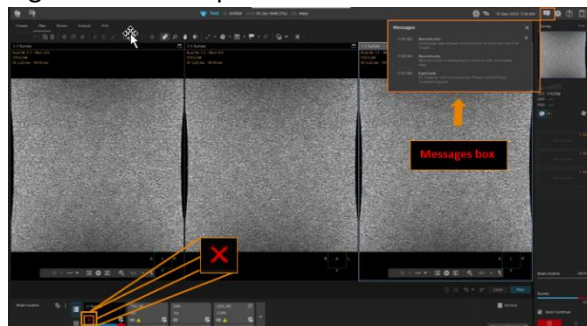
Figure 5. UI example SW Version R11.

- 4.3. When scan aborts occur the symbol is shown and applicable messages are presented in the message box (see Figure 5 and Figure 6 examples)
  - 4.3.1 Check the status of the error messages in the User Interface (UI) screen. Click to expand the message box in case previous messages are hidden, see orange box in Figure 5 and Figure 6 below. If possible, correct the issue that is relevant to the error shown and continue scanning, for example:
    - “RF door must be closed while performing scan. Scan aborted.”
    - “Patient support is moved while scanning, scan stopped.”
    - “Coil A (or B) failure, coil disconnected?”.

- 4.3.2 If, after a scan abort, one of the following conditions occur five times in a row stop scanning immediately and contact Philips Service to describe the problem:
  - If there is no error message in the message box
  - If the error message meaning is not clear
- 4.3.3 If the error message “Gradient amplifier Rack Fault” is received two times in a row, or if the error message “Gradient amplifier Rack Fault” is preceded or followed by an aborted scan with no message, then stop scanning immediately and contact Philips Service to describe the problem.
- 4.3.4 If you encounter any of these conditions described in 4.3.2 or 4.3.3 do not attempt any additional/further scans, including without limitation do not attempt any phantom scanning until your system has been checked and released by a Philips Service representative.
