URGENT Field Safety Notice

Philips Allura R8.2.x System

Software issue potentially resulting in loss of imaging (X-ray) functionality

04-Jul-2025

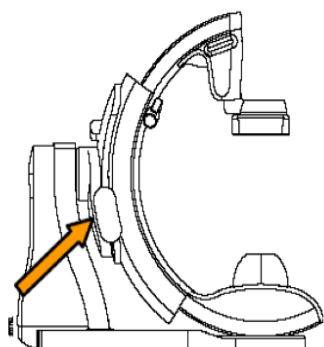
Figure 1- System Identification Label

The System Product Name and Model Number can be found on the System Identification Label located on the System stand (Figure 1). The software version of the Philips Allura systems can be identified during start-up (Figure 2).
