Customer Safety Advisory Notice MR040/25/S

## CUSTOMER SAFETY ADVISORY NOTICE

### Inspection of Magnet Venting System

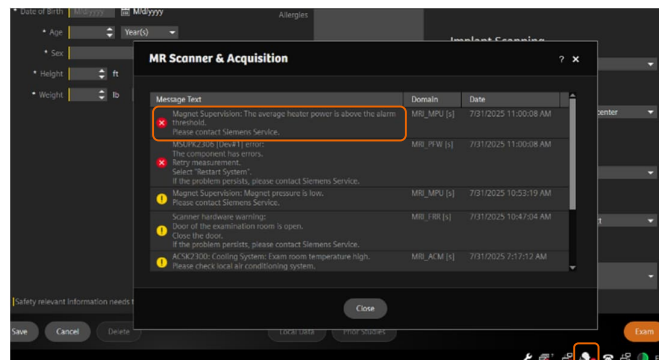
Figure 1 - Error message: "Magnet Supervision: The average heater power is above the alarm threshold. Please contact Siemens Healthineers Service."

- If the error message shown in Figure 1 appears on your host computer, do not reboot the system. Please call your local Siemens Healthineers service organization.
