**NEW****URGENT: FIELD SAFETY NOTICE – MMS-25-5342****BD Alaris™ Syringe Pumps****REF:** See Table 1 and 2 **Serial Numbers:** See webpage link**Type of Action:** Field Work**Attention: Clinical Personnel, Risk Managers, Biomedical Personnel, Purchasing Managers**

BD is conducting a Field Safety Corrective Action for specific serial numbers of BD Alaris™ Syringe Pumps and specific spare kits. According to our distribution records your organisation may have received the impacted product listed in Table 1 and Table 2.

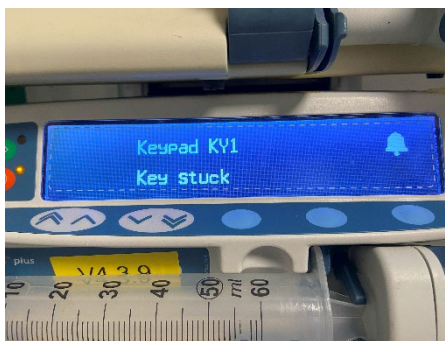
Based on customer feedback, BD has identified that a potential manufacturing defect affecting certain BD Alaris™ Syringe Pumps related to keypad functionality. It has been observed that specific lots of the keypad components may exhibit unintended behaviour impacting the “On/Off”, “Hold” and “Run” keys.

Specifically, the affected pumps may experience one or more of the following failure modes:

- The pump may enter “Tech Mode” autonomously during power-up.
- Keypad buttons may become unresponsive, preventing normal operation.
- A “KY1” error may be displayed, indicating a stuck key (see Picture 2 below)

**Picture 2: KY1/Stuck Key Error Displayed**

- If your Service Organisation is not BD, they will contact you if any additional pumps were fitted with the impacted parts.
- Continue to use the Alaris™ Infusion pumps with their existing labeling and Directions for Use. In case you observe the pump presenting with the described issue, immediately remove it from service for inspection by Qualified Service Personnel. Use an alternative syringe pump in the meantime.
