Urgent Field Safety Notice

Potential for Suspension of Dynamic Sensing Algorithm

Aurora EV-ICD™ (DVEA3E4) UDI: 00763000368463, Clinical EV-ICD (DVEX3E4) <00763000217891

Medtronic Reference: FA1511

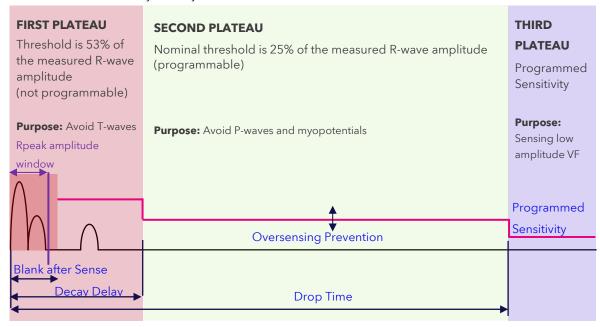
Figure 1- Operation of Sensing Thresholds - The first plateau duration ("Decay Delay") is nominally 360 ms, the second plateau duration ("Drop Time") is nominally 1500 ms, and the third plateau lasts until another sensed beat. R-wave amplitude measurements take place during "R peak amplitude window" shown above, nominally 128.75 ms (not programmable).

The dynamic sensing algorithm may become suspended at the first plateau if the following sequence of events occurs:

- 1. Charge-end occurs within 128.75ms of the prior sensed beat, thus interrupting the in-progress R-wave measurementsuspension of the dynamic sensing algorithm occurs and the sensitivity plateau becomes static at 53%.
- 2. The sensitivity plateau will remain at 53% until a subsequent **R-wave amplitude exceeds this value.** In the case of a significant drop in R-wave amplitudes, delay in HV therapy delivery can occur.

Medtronic has implemented manufacturing changes, and devices manufactured with this update are not susceptible to this delay. In previously distributed devices, a device interrogation with the CareLink™ SmartSync™ Aurora EV-ICD™ application (D00U025) on CareLink SmartSync Device Managers will resolve the potential for this behavior (see Appendix B).
