Field Safety Notice

MR systems with SW version R11.1 and R12.1  
Wrong stiffness values displayed with MR Elastography (MRE) in PACS

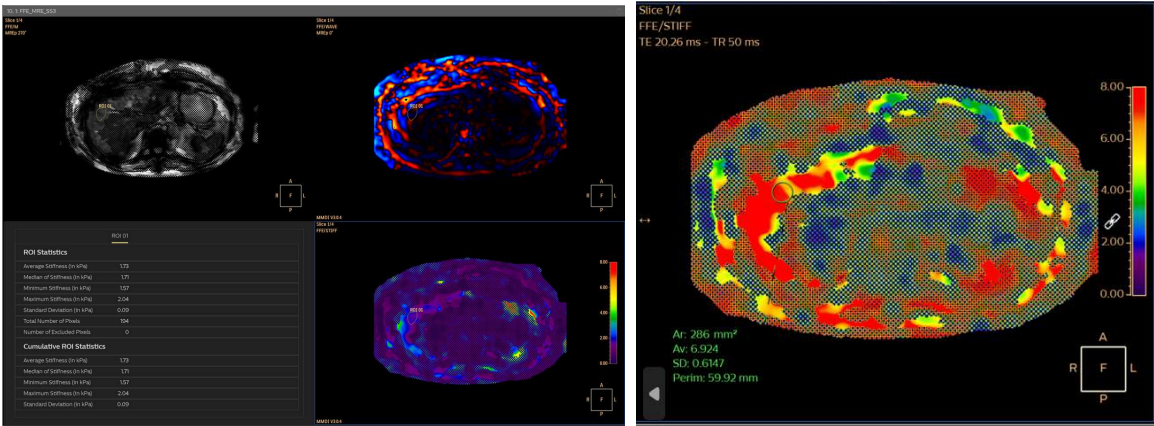
Philips has identified potential stiffness value errors when viewing exported MR Elastography (MRE) stiffness maps to viewer Picture Archiving and Communication System (PACS).

Figures 1 and 2 show the stiffness map of the human liver in the MRE viewer PACS (Figure 1) and on the MR Console viewer (Figure 2). In the screenshots, the MRE viewer PACS indicates around 2 kPa (Figure 1, wrong stiffness values), which can be associated with healthy tissue, while the general viewing environment in the MR Console viewer indicates almost 8 kPa (Figure 2, correct stiffness values), which can be an indicator of cirrhosis.

Figure 1: MRE stiffness map (lower right) in the MRE viewer PACS.

Figure 2: MRE stiffness map in the MR Console viewer

- You may continue to use your system(s) in accordance with the intended use.
  - To avoid the potential issue of MRE stiffness value errors, view stiffness maps in general viewing environment (MR Console viewer) and not MRE viewer PACS.
- Circulate this notice to all users of this device so that they are aware of the issues and associated hazard/harm.
- Please retain this Field Safety Notice with your system(s) until the software upgrade is installed; ensure the notice is in a place likely to be seen/viewed.
- Please complete and return the attached response form to Philips MR promptly and no later than 30 days from receipt of this letter via email to: *<Market to insert local contact>*

A Philips representative will contact you to schedule time for a Field Service Engineer (FSE) to install a software upgrade to resolve the issues beginning in January 2026 (reference FCO78100585, FCO78100620).
