Olympus reference: QIL FY26-EMEA-17-FY25-009-A Thunderbeat Probe Fracture and Tissue Pad Detachment

URGENT FIELD SAFETY NOTICE

RE: THUNDERBEAT™ Hand Instrument

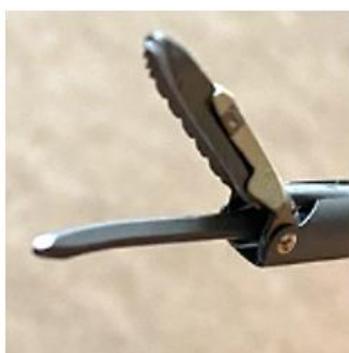
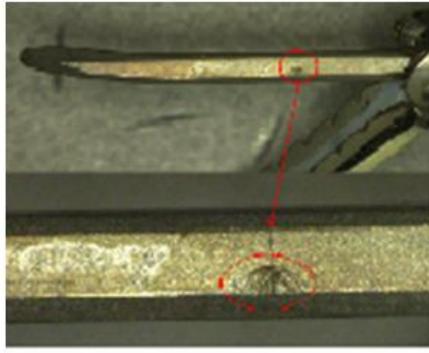
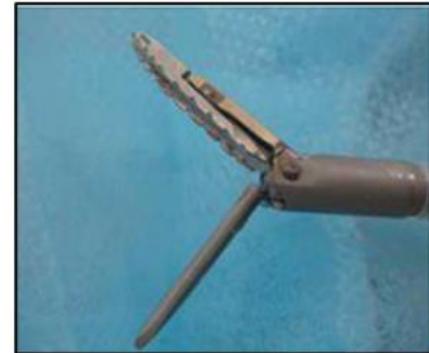
- **Probe tip damage or breakage** - Multiple instances where probe tips of THUNDERBEAT™ Type S hand instruments have become damaged or broken during use (reference example in Figure 1).
- **Tissue pad issues** - Reports of tissue pad damage or detachment from the instruments (reference example in Figure 2).

Olympus was made aware, via customer complaints, of reports where probe tips of THUNDERBEAT™ hand instruments are becoming damaged or are breaking (reference example in Figure 1), as well as instances of tissue pad damage or detachment (reference example in Figure 2). Investigations by Olympus demonstrated that these issues can occur when the instructions and warnings in the IFU are not followed, specifically, taking very large bites of tissue, contact with metal while activating, and activation without tissue between the jaws. However, due to a continuation of occurrences of this issue, Olympus is removing potentially affected models of THUNDERBEAT™ hand instruments from the market.

Figure 1. Example of Thunderbeat Probe in accordance with specifications (left), Cracked Probe (Center) and Probe Fracture (right)

A broken probe tip or a damaged tissue pad may lead to various patient harms. Of these harms, the most common harm is a foreign body in the patient due to a probe tip and/or tissue pad that becomes damaged and breaks off the device during use. When this occurs, this can also potentially result in a prolonged operative time, the requirement to perform imaging examinations, or an additional surgical procedure to locate and remove the broken device fragment. In rare circumstances, tissue damage could occur due to exposed sharp edges on the device when the probe tip breaks or becomes damaged. Additionally, bleeding may occur if the tissue pad fails or probe breaks, causing an inadequate seal. Post-operative bleeding events could, in rare circumstances, result in life-threatening injuries. Olympus has received one complaint of a postoperative death due to hemorrhage; however, the device was not returned to Olympus for further evaluation and there was insufficient information in the reported complaint details provided to Olympus to conclude the hemorrhage was causally related to probe tip or tissue pad damage.

1. Examine your inventory for affected Thunderbeat hand instrument models as listed on page 1 of this FSN.
2. **Immediately cease use of all affected devices and quarantine the products.**
3. If you have affected products in your inventory, please contact Olympus with regard to return of affected products. Olympus will issue a credit to your facility upon return of your affected product
4. Olympus requests that you acknowledge receipt of this FSN.
5. If you have further distributed THUNDERBEAT™ devices, please identify your customers and forward this notice to them immediately.

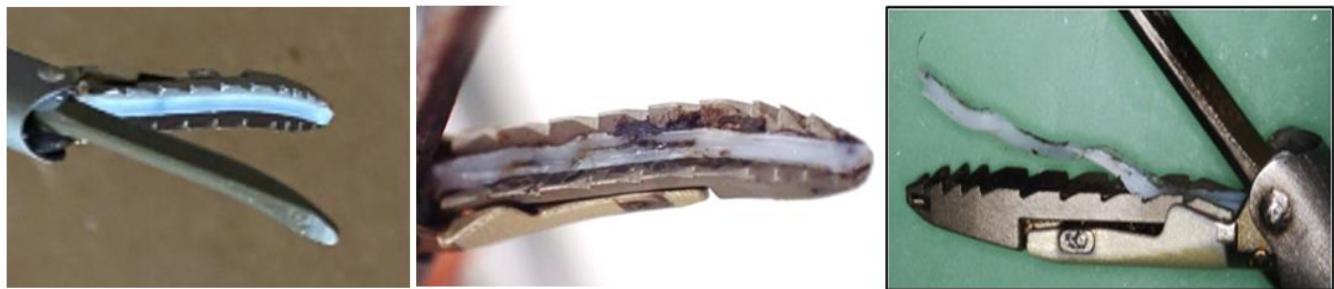
Figure 2. Example of Thunderbeat Probe in accordance with specifications (Left), Tissue Pad Deformation (Center), Tissue Pad Detachment (Right)
