## Field Safety Notice

MR systems with SW version R11.1 and R12.1

Wrong stiffness values displayed with MR Elastography (MRE) in PACS

03-Dec-2025

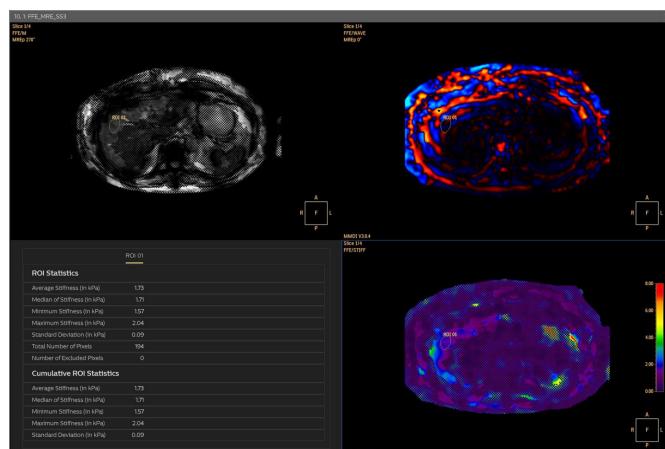
Philips has identified potential stiffness value errors when viewing exported MR Elastography (MRE) stiffness maps to viewer Picture Archiving and Communication System (PACS).

Figures 1 and 2 show the stiffness map of the human liver in the MRE viewer PACS (Figure 1) and on the MR Console viewer (Figure 2). In the screenshots, the MRE viewer PACS indicates around 2 kPa (Figure 1, wrong stiffness values), which can be associated with healthy tissue, while the general viewing environment in the MR Console viewer indicates almost 8 kPa (Figure 2, correct stiffness values), which can be an indicator of cirrhosis.

Figure 1: MRE stiffness map (lower right) in the MRE viewer PACS.

- You may continue to use your system(s) in accordance with the intended use.
- To avoid the potential issue of MRE stiffness value errors, view stiffness maps in general viewing environment (MR Console viewer) and not MRE viewer PACS.
- Circulate this notice to all users of this device so that they are aware of the issues and associated hazard/harm.
- Please retain this Field Safety Notice with your system(s) until the software upgrade is installed; ensure the notice is in a place likely to be seen/viewed.
- Please complete and return the attached response form to Philips MR promptly and no later than 30 days from receipt of this letter via email to: **FCO.Nordic@philips.com**. Completing this

A Philips representative will contact you to schedule time for a Field Service Engineer (FSE) to install a software upgrade to resolve the issues beginning in January 2026 (reference FCO78100585, FCO78100620).

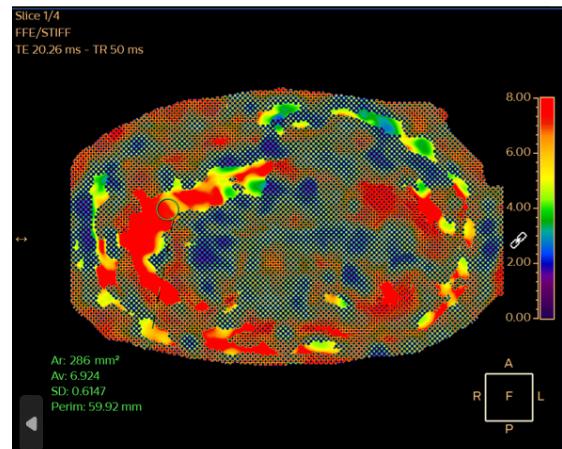
Figure 2: MRE stiffness map in the MR Console viewer
