**URGENT Field Safety Notice****Philips Azurion R3.1 Systems**

Potential loss of imaging (X-ray) functionality, and/or loss of motorized movement may result in a delay or termination of procedure

12-Dec-2025

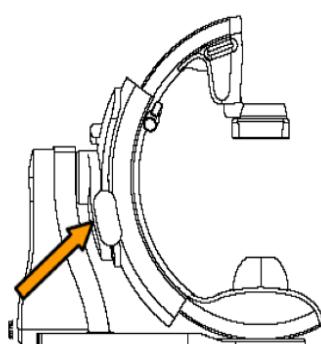
Figure 1- System Identification Label

The System Product Name and Model Number can be found on the System Identification Label located on the System stand (Figure 1). The software release version of the Philips Azurion systems can be identified during start-up (Figure 2).
