Updated Field Safety Notice

Philips MR systems with MR Elastography (MRE)
Potential for inaccurate (lower) liver stiffness measurements

12/05/2026

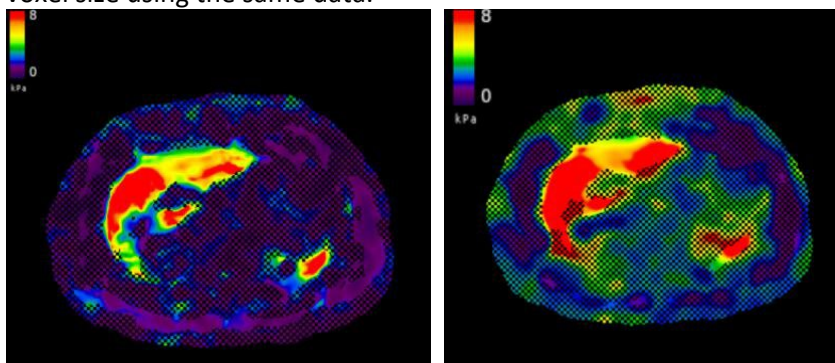
Philips has become aware through the MRE software system developer Resoundant about an issue affecting MRE stiffness measurements when a specific range of image reconstruction parameters is used in combination with Resoundant’s algorithm. Specifically, the reconstruction voxel size settings in the default MRE scan protocol are too small, which can potentially lead to inaccurate liver stiffness measurements (lower values). See Figure 1.

Figure 1. An example of what may occur. The left Elastogram was obtained with 1.17mm reconstruction voxel size from default MRE protocol and shows stiffness measurements in the liver are biased toward lower values. The right Elastogram was obtained with 1.65mm reconstruction voxel size using the same data.

4. On the Geometry tab make the following changes
 - Change the **FOV RL** to 480 mm
 - Change the **Recon voxel size RL** to 1.5mm
 - Accept the changes
 - NOTE: For the FFE_MRE_4sl protocol on Release 12 systems, it may be necessary to re-enter the Recon voxel size RL of 1.5mm if the system defaults to 1.48mm.
