## Subject: Field Safety Notice - Heating of nordicAudio Headsets

FSCA Identifier: CAPA-95

Type of action: Field Safety Corrective Action

Date: 2026-05-07

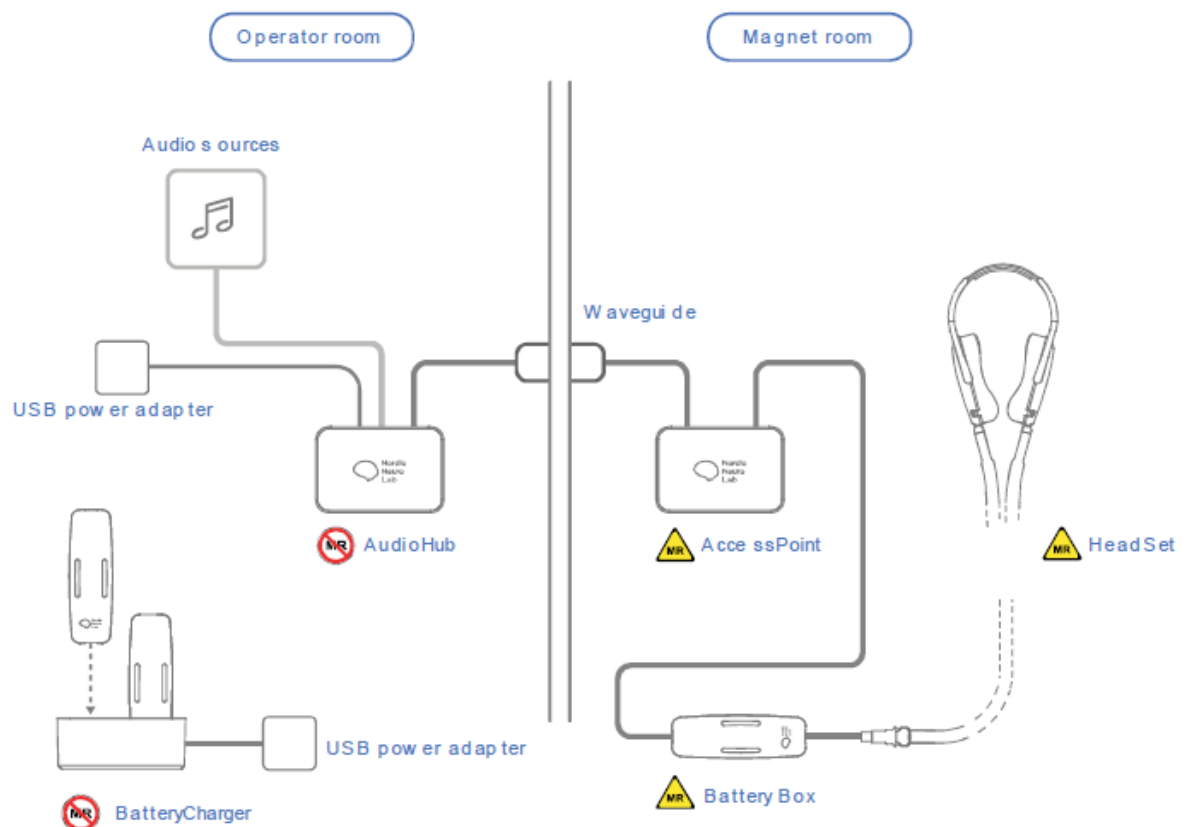
nordicAudio consisting of a MR compatible headphone with optical data transmission, Battery unit for powering the headphones, AccessPoint for interfacing between commercial audio and optical transmission to headset.

It was reported during a patient scan, that the nordicAudio version 1.0.0 (nAu) had become uncomfortable as it became warm during the scan. Investigating the effected product showed clear indications that the heating has occurred due to overheating of the cable traps. The purpose of the cable traps is to reduce the antenna effect of the cable between the HeadSet and the BatteryBox. When the cable traps where degraded, the increased antenna effect led to overheating in the ear cups. Neither the patient nor the operator was injured.

Induced currents in conductive parts leading to heating of cable traps causing traps to lose function. This in turn can lead to increased antenna effect causing heating of the ear cups.

- *Immediately cease use of the product*
- *Extend the information to your accounts that may have this product in their possession*
- *Identify and quarantine any of the subject device in your facility*
- *Acknowledge receipt of this notice by completing and returning the attached form (Scanned or email confirmation is sufficient)*
- *NordicNeuroLab will contact you to coordinate the return and upgrade of your HeadSet.*
