URGENT Field Safety Notice

Philips Azurion and Allura Systems

Potential loss of imaging functionality (Allura/Azurion), loss of motorized movement (Allura), or loss of data (Allura) due to aging Hard Disk Drives

30-APR-2026

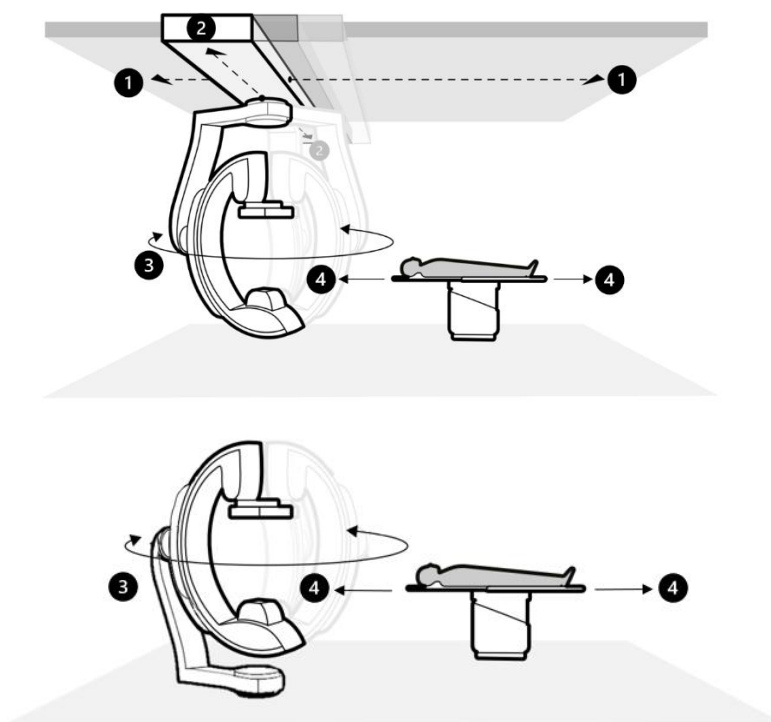
Figure 1 – Manual movements of the ceiling-mounted system (top) and floor-mounted system (bottom)

- Circulate this Urgent Field Safety Notice to all users of the system so that they are aware of the issue and follow the instructions below.
- In case motorized movements are unavailable, the stand can be manually repositioned using the handgrips and brake controls located on both sides of the stand. For ceiling-mounted systems, manual longitudinal (1), transversal (2) and rotational (3) stand movements remain available. Note: Transversal stand movements (2) are only available for ceiling-mounted systems with the FlexMove option. For floor-mounted systems, only rotational (3) stand movements remain available. The table longitudinal position (4) can be adjusted manually, when the table is not tilted (see Figure 1 below).

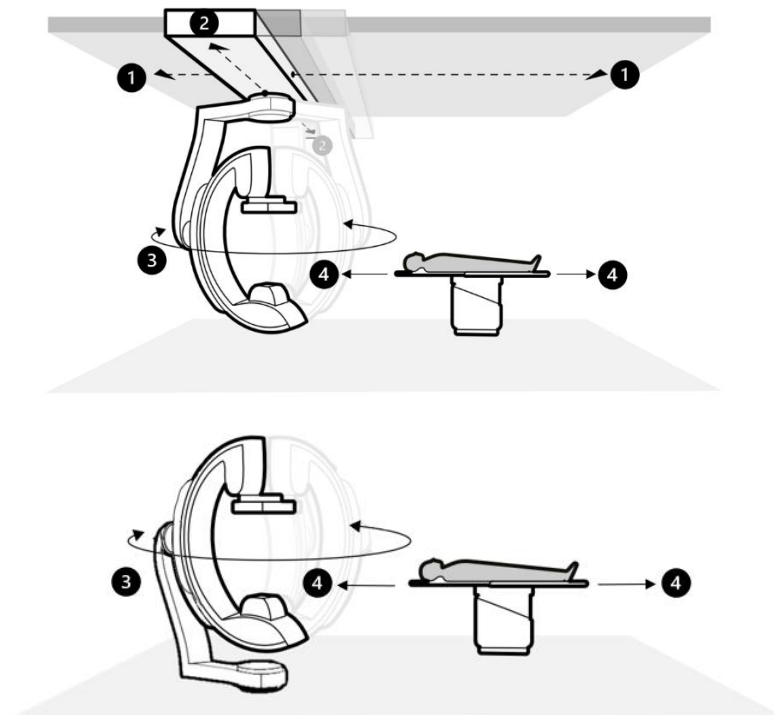
Figure 1 – Manual movements of the ceiling-mounted system (top) and floor-mounted system (bottom)

- Circulate this Urgent Field Safety Notice to all users of the system so that they are aware of the issue and follow the instructions below.
- In case motorized movements are unavailable, the stand can be manually repositioned using the handgrips and brake controls located on both sides of the stand. For ceiling-mounted systems, manual longitudinal (1), transversal (2) and rotational (3) stand movements remain available. Note: Transversal stand movements (2) are only available for ceiling-mounted systems with the FlexMove option. For floor-mounted systems, only rotational (3) stand movements remain available. The table longitudinal position (4) can be adjusted manually, when the table is not tilted (see Figure 1 below).
