DATE: 11<sup>th</sup> August 2026 **FSCA/FSN REF.: APM-26-06129**

**URGENT: FIELD SAFETY NOTICE (FSN)**  
**ForeSight Oximeter cable**

| Product name | Product Code (REF) | Lot number / Serial number | UDI-DI |
|---|---|---|---|
| ForeSight Oximeter cable | HEMFSM10 | All serial numbers manufactured between June 01, 2021, through June 30, 2026 | 00690103210927 |

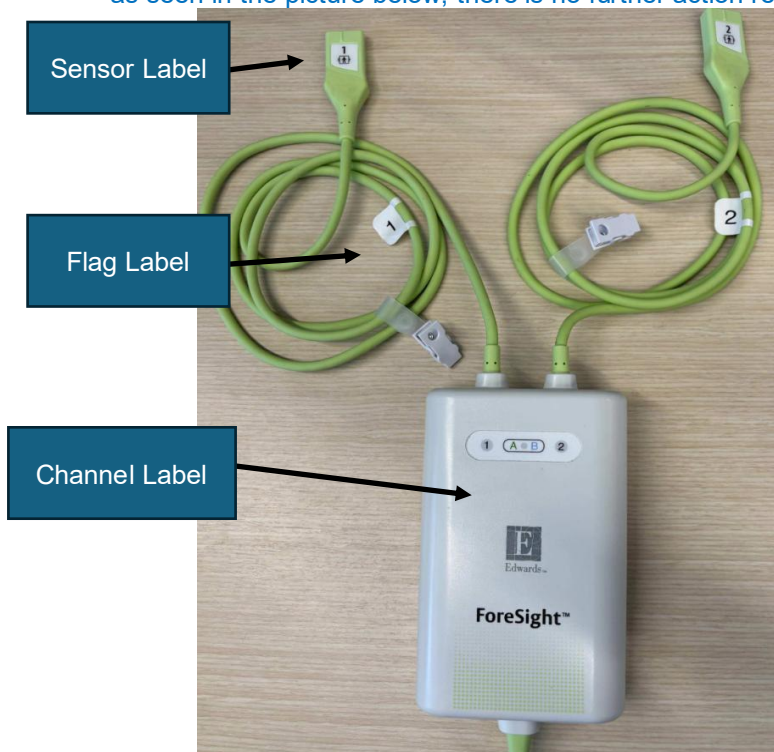
Based on customer feedback, BD has identified that during manufacturing, the laterality identification labels may be missing or inaccurately placed on the device. There is potential that the labels on the green cables may have been switched, with the channel 1 cable labelled as channel 2, and the channel 2 cable labelled as channel 1 [CS4.1][KL4.2]. This will lead to a mismatch as to the left and right values displayed on the monitor and what the labels indicate on the cables.

Should this potential issue occur during use, the values displayed on the monitor will be switched and will represent the opposite region

| Type of Action to mitigate the risk | | | | | | | |
|---|---|---|---|---|---|---|---|
| Provide further details of the action(s) identified | | | | <p>If either of the labels are missing, or the flag label and/or the sensor label do not match the channel label on the housing, quarantine the device and return the completed response form to BD at <a href="mailto:BDFieldActions@bd.com">BDFieldActions@bd.com</a> for BD Technical Services to contact you.</p> | | | |

1. Verify for the presence of the flag, sensor, and channel labels on the device.
2. Verify that the flag and sensor labels correspond to the correct channel label (A1 on left / B2 on right) on the housing (See picture below for correct label placement).
3. If either of the labels are missing, or the flag label and/or the sensor label do not match the channel label on the housing, quarantine the device and return the completed response form to BD at [BDFieldActions@bd.com](mailto:BDFieldActions@bd.com) for BD Technical Services to contact you.
4. If the flag and sensor labels correctly correspond to the channel labels, as seen in the picture below, there is no further action required.

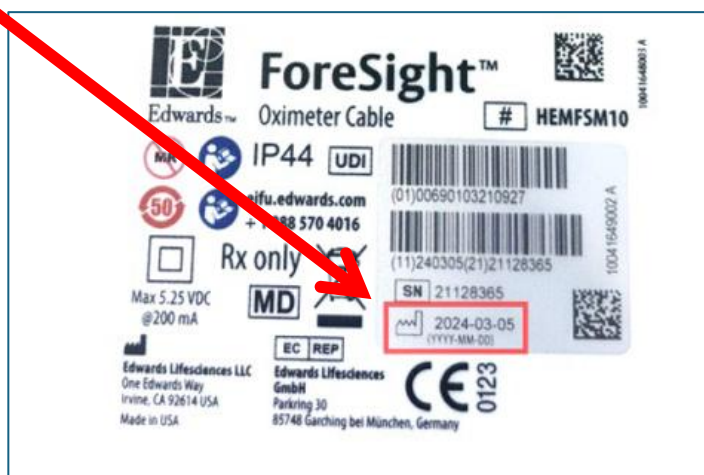
## Appendix 1 – Manufacturing date identification

This issue may affect certain devices manufactured between June 01, 2021, and June 30, 2026. Refer to the following image to identify the location of manufacturing date.
