04 August 2026

| <b><i>Urgent Field Safety Notice – CARDIOROOT Woven grafts</i></b> | |
| <b>Manufacturer's Reference Number:</b> | <i>RC045 – 1574541</i> |

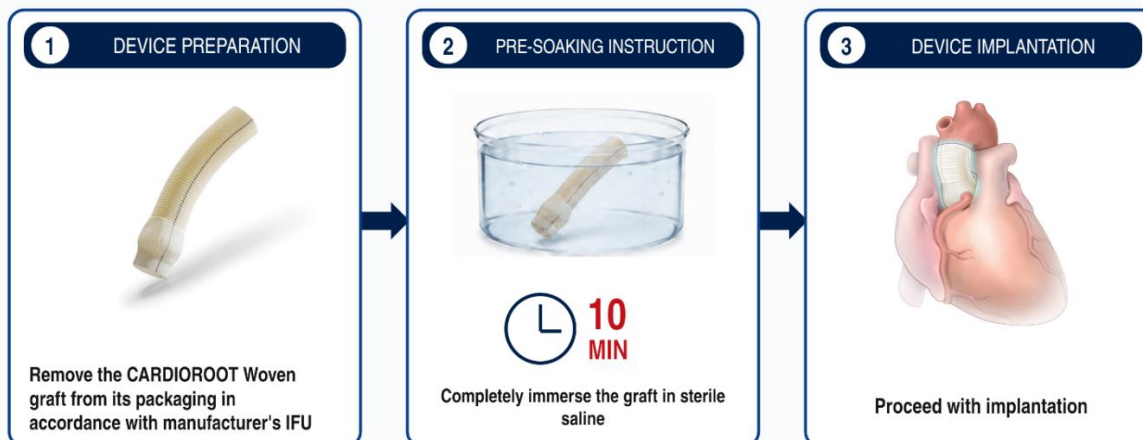
### PRE-SOAK CARDIOROOT WOVEN BEFORE IMPLANTATION

Immerse completely in sterile saline at room temperature (15–25°C) for 10 minutes

- Failure to pre-soak the graft for 10 minutes may increase the potential for perioperative bleeding through the affected graft wall during implantation.

- **Pre-soaking instruction:** After removing the graft from its packaging, the CARDIOROOT Woven graft shall be immersed in sterile saline solution at room temperature (15-25°C) for **10 minutes** before implantation. The prosthesis should not be allowed to dry out prior to implantation. Once implanted, confirm hemostasis of the CARDIOROOT device.
