## Subject: Field Safety Notice - Heating of nordicAudio Headsets

FSCA Identifier: CAPA-113

Type of action: Field Safety Corrective Action

Date: 2026-08-20

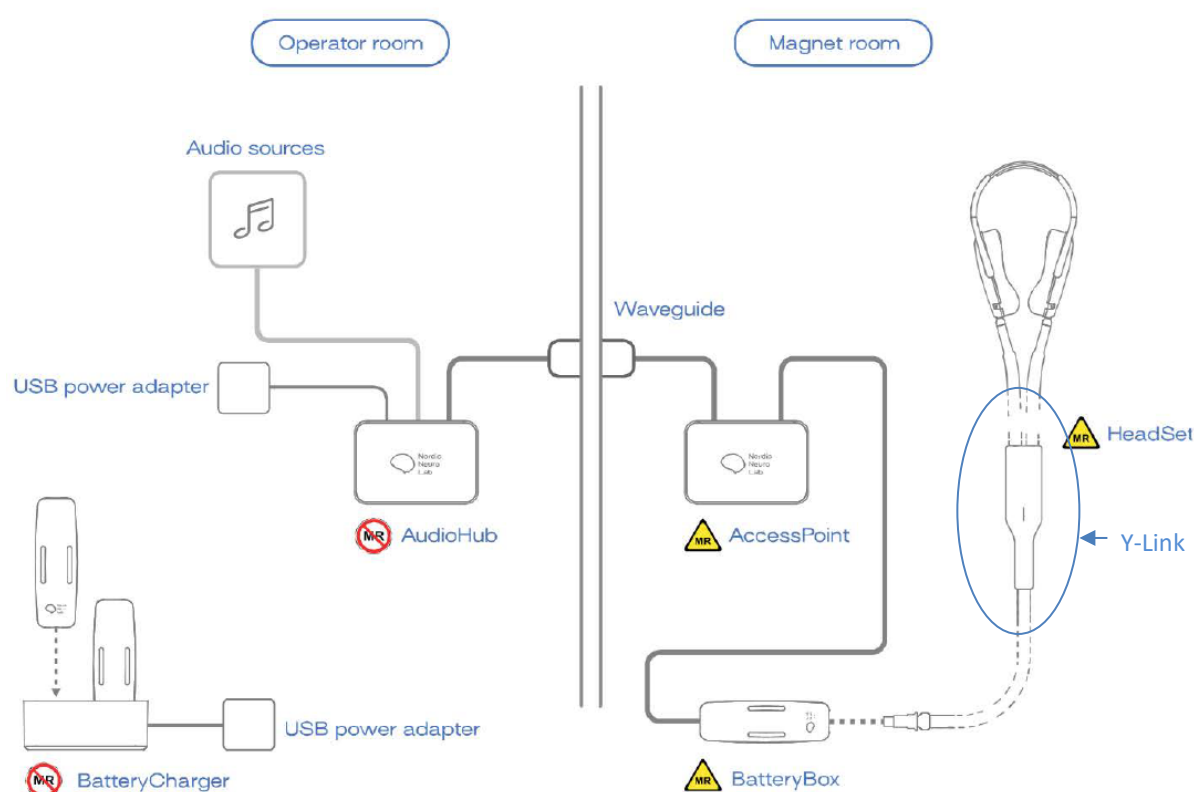
nordicAudio consisting of a MR compatible headphone with optical data transmission, Battery unit for powering the headphones, AudioHub for interfacing between commercial audio and optical transmission to headset.

Following the patient scan, it was reported that the Y-link, which houses the RF traps and is located on the cable between the HeadSet and the Battery Box of a nordicAudio HS (1.5T) version 1.0.2 (nAu), had overheated, resulting in deformation of the enclosure. Investigation of the affected product indicated that the RF traps within the Y-link were the likely source of heat. No injury to the patient or operator was reported.

Induced currents in conductive components, combined with elevated internal resistance within the cable traps, may result in cable traps heating above the accepted test threshold ( $>43^{\circ}\text{C}$ ), thereby increasing the risk of patient burns.

- *Immediately cease use of the product*
- *Extend the information to your accounts that may have this product in their possession*
- *Identify and quarantine any of the subject device in your facility*
- *Acknowledge receipt of this notice by completing and returning the attached form (Scanned or email confirmation is sufficient)*
- *NordicNeuroLab will contact you to coordinate the return of the affected HeadSet.*
