## URGENT Field Safety Notice

### EPIQ Elite v14.0 Software Issue with C5-1 Transducer

AUG-2026

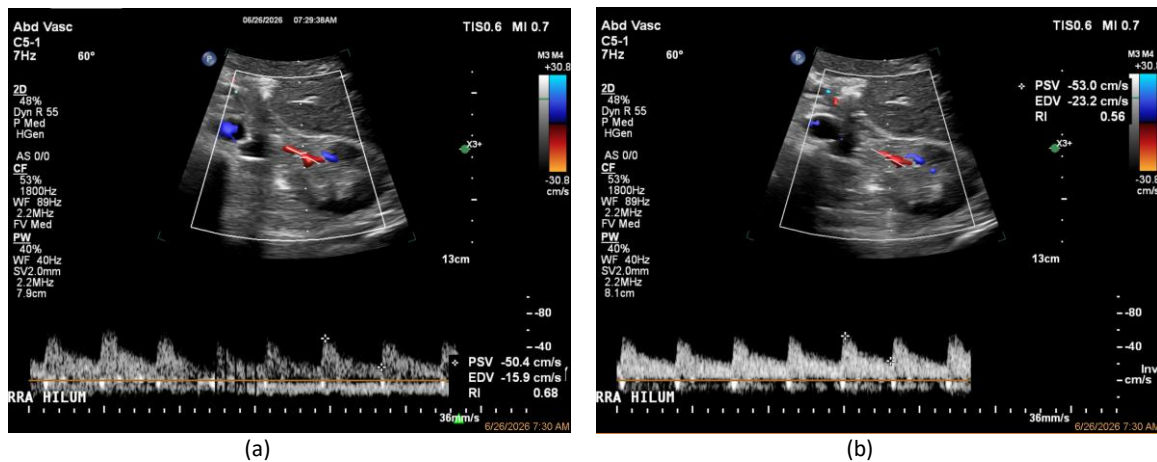
When using a Philips EPIQ Elite system with the C5-1 transducer with the Abd Vasc TSP in Pulsed Wave Doppler mode, the visual representation of the Pulsed Wave sample volume (SV) gate is slightly offset (shallower) to the actual location of the Pulsed Wave measurement. Under default conditions, it will result in an approximate 2mm offset. In larger vessels, the defect may result in reduced signal, which the user may compensate for by increasing PW Gain on the system. In smaller vessels or stenotic flow, the defect may result in underestimation in severity of stenosis. This issue could result in delayed diagnosis or treatment. Inaccurate data may lead to misdiagnosis and incorrect treatment decisions if not identified or corroborated with other diagnostic tools.

Figure 1: Example with small vessels. (a) Ideal Positioning - SV placed near center of vessel lumen. Weaker amplitude signal with PSV of 50.4cm/s. (b) Positioning Offset - SV placed slightly posterior to the vessel resulting in a stronger PW Doppler trace. PSV of 53.0cm/s.

- Due to possibility of a weak PW Doppler Signal on EPIQ Elite running 14.0 SW, customers are advised not to use C5-1 Abd Vasc Tissue Specific Preset (TSP). Please use a different TSP (e.g., Abd Gen, Abd Renal) within C5-1. Please note that this issue (i.e., Weak PW Doppler signal) is restricted to the Abd Vasc TSP with C5-1 on EPIQ Elite running SW 14.0 only.
- Otherwise, you may continue to use your device in accordance with the IFU.
- Circulate this notice to all users of the device so that they are aware of the product issue and associated hazard / harm.
- Post this notice near the affected unit(s) for ease of reference

Philips will be implementing a software correction free of charge to address the issue. A Philips representative will contact you to schedule the correction (reference FCO79500580).

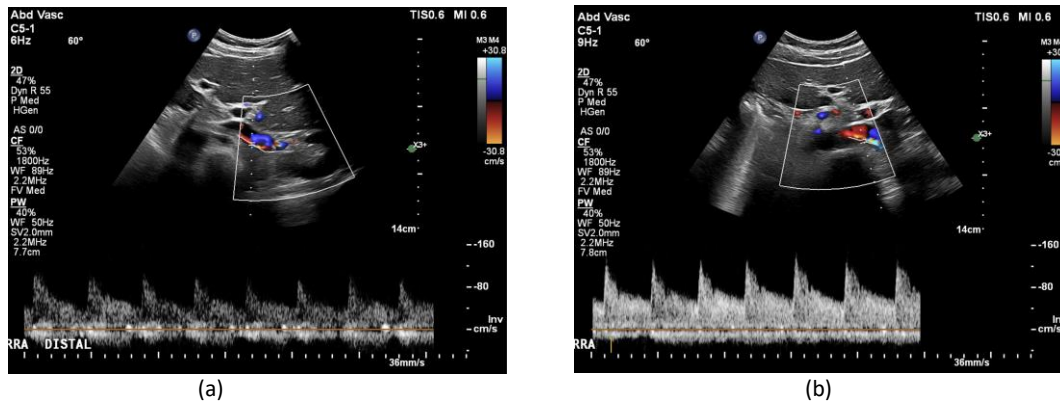
Figure 2. Example with large vessels. (a) Ideal Positioning - SV volume placement in center of lumen. Signal is weak and is not what the user would expect to see given the normal color Doppler signal displayed (Typically gain would be increased by user). (b) Positioning Offset - SV is placed deep to the periphery of the vessel, and a normal PW trace is observed
