# **IMPORTANT PRODUCT NOTICE**

7 December 2023

RE: Roadmap pro dark image

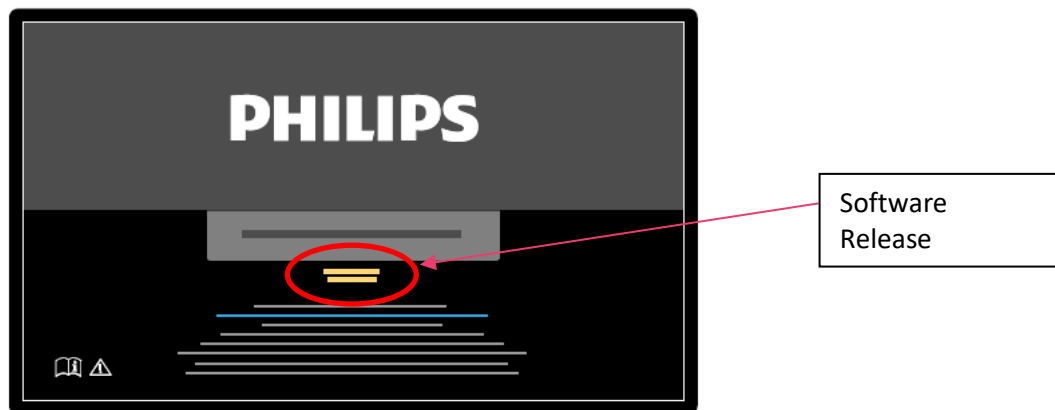
Figure 2: System start-up screen

The software version of the Philips Azurion system can be identified during start-up (Figure 2).

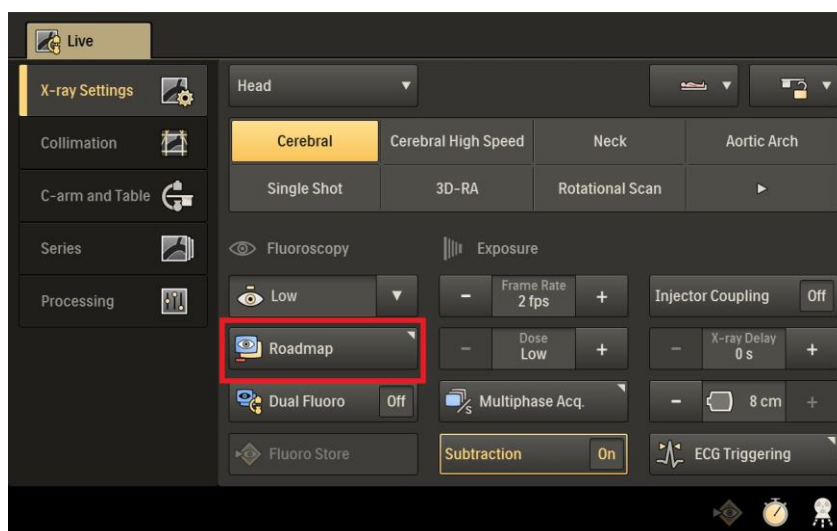
Figure 3: System with Roadmap Pro

This issue only happens on Philips Azurion systems with Roadmap Pro.

The availability of the Roadmap Pro functionality can be identified on the Touch Screen Module (TSM) (Figure 3).

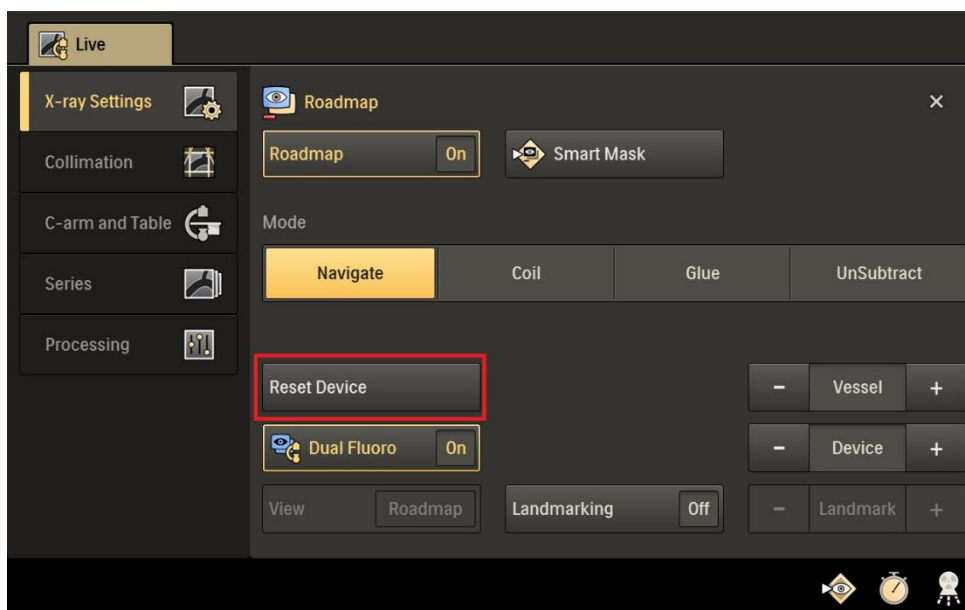
Figure 4: Location of “Reset Device” button on the TSM.

During the device phase of Roadmap Pro, a user may experience a dark image that is not clinically usable. The dark image may result after the user performs a pedal tap (shortly touching the footswitch pedal without generating an Xray image). The pedal tap may cause a dark image with the next fluoroscopy run.

- Prevent pedal tapping (i.e. pressing the footswitch and releasing it before the first X-ray image has been created)
- In case of an inadvertent pedal tap during the device phase, restart the device phase by using the 'Reset Device' button in the Roadmap menu on the TSM (Figure 4).
