## Field Safety Notice

Magnetic Resonance (MR) imaging systems with Diffusion Tensor Imaging (DTI)  
Incorrect data in Enhanced MR DICOM Export

August 2026

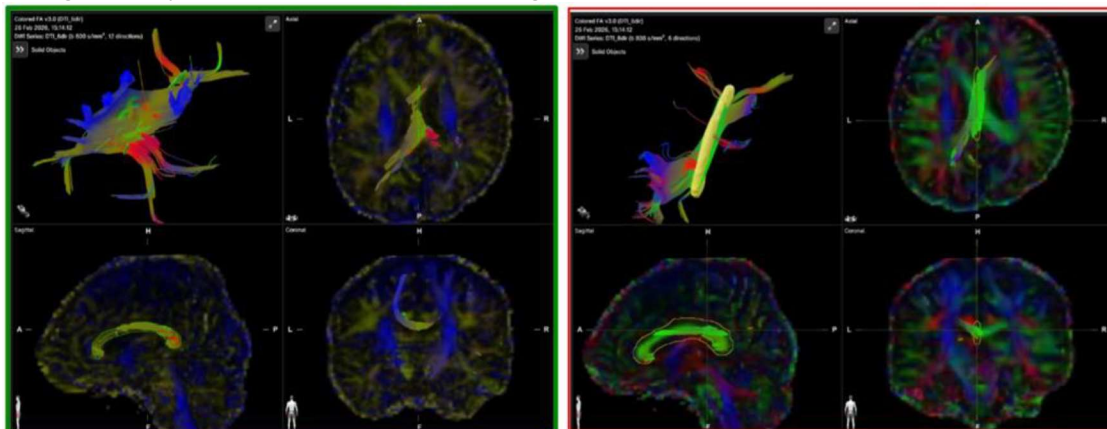
When exporting diffusion tensor imaging (DTI) scans from a Philips MR system using the Enhanced MR DICOM format, the exports contain incorrect data (diffusion directions). If the Enhanced MR DICOM export is used in conjunction with third-party software for tractography (e.g. for mapping nerve fiber pathways in the brain), the software will not be able to correctly process the DTI data for reconstruction (see Figure 1).

Figure 1. Example of a correct reconstruction image (Left) and an incorrect reconstruction image (Right) resulting from processing an Enhanced MR DICOM export with incorrect data. The image on the right clearly exhibits abnormal fiber tracking.

If an incorrect reconstruction image is used for treatment planning, it may lead to inadequate or inappropriate treatment. A surgical procedure planned with incorrect data could result in injury to

- To prevent the issue from occurring while Philips is developing the software solution, use the Classic DICOM transfer option for exporting DTI scans (see instructions below).
  - Open the **DICOM Configuration**, click **Settings and Tools (F10)**

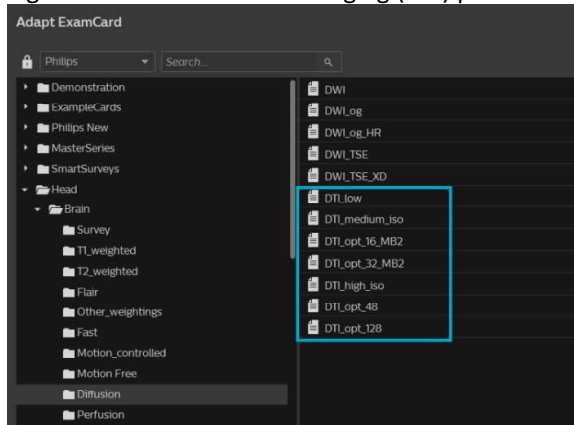
Figure 2. Diffusion Tensor Imaging (DTI) protocols

To identify if your system has Diffusion Tensor Imaging (DTI), navigate to the **Philips\Head\Brain\Diffusion** folder within the Philips protocol database and verify if your system contains the protocols shown in Figure 2.
