**FIELD SAFETY NOTICE*****Arjo Carevo shower trolley***

| <b>Product Issue:</b> | Carevo shower trolley torsion spring defect that may increase likelihood of incomplete handle locking potentially contributing to side support opening. |
| <b>Field Safety/Correction Notice:</b> | FSN_2980188-3 |

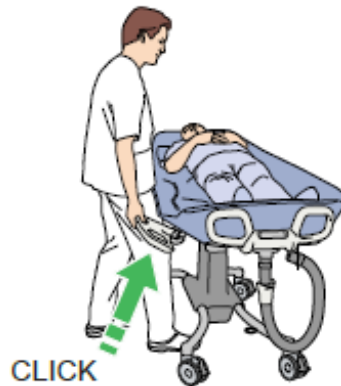
1. When the side panels snap into place, a characteristic "click" sound can be heard.

*Pic. 1. Fold up the side support from the down folded position..*

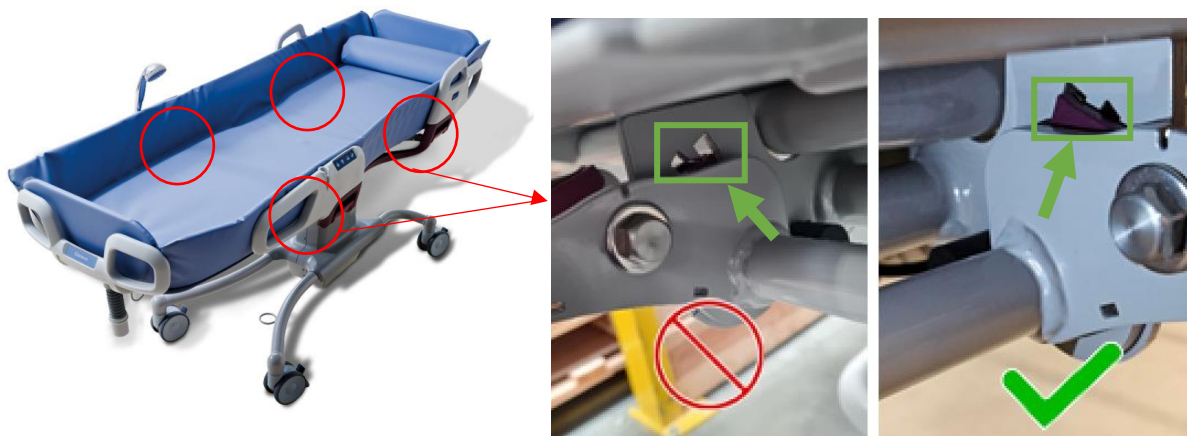
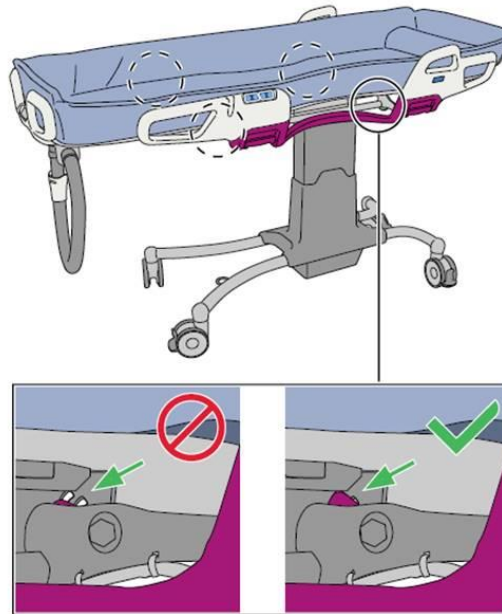
2. **Ensure both latches on each side support are in the locked position.** Failure to comply may result in unintentional side support opening while handling a patient/resident, posing their fall risk. Refer to picture 2.

*Pic. 2 Latches in the correct and incorrect locked position and their location on the device (actual device photo vs. illustration from IFU)*

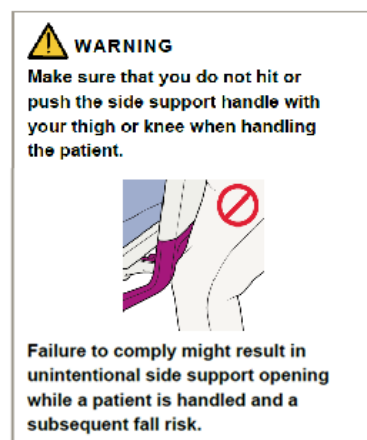
3. **Avoid hitting or pushing the side support handle with your thigh or knee when handling the patient.** Failure to comply may result in unintentional side support opening while handling a patient, posing a fall risk. Refer to Pic.3.

*Pic. 3. Warning regards to knee hitting the handle.*
