## **URGENT Field Safety Notice**

### **Philips Azurion Systems**

Potential loss of imaging functionality, loss of motorized movement, and/or loss of data due to SSDs that are not specified in the Medical Device File

06-OCT-2026

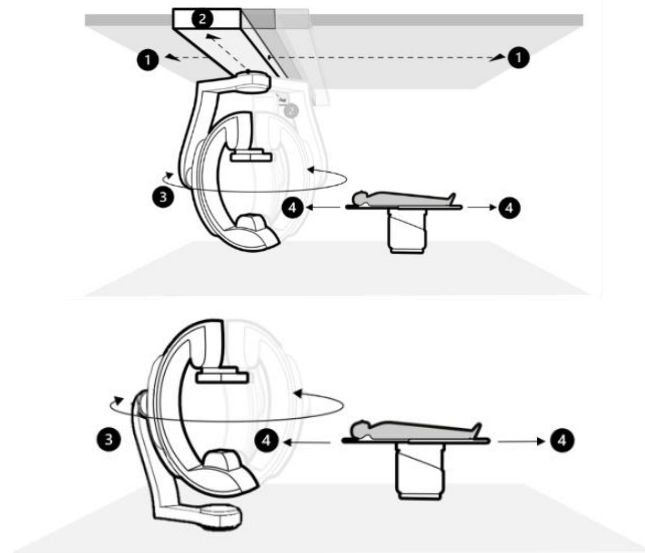
*Figure 1 – Manual movements of the ceiling-mounted system (top) and floor-mounted system (bottom)*

When an SSD does not perform as intended, the symptoms depend on the PC in which the SSD is installed and the function being used. This may result in loss of imaging functionality or motorized movement, a blank or black display, and/or the inability to store newly acquired images or access previously acquired images.

- Affected systems may continue to be used in accordance with their Instructions for Use (IFU) and the instructions below.
- If motorized movements become unavailable, the stand can be manually repositioned using the handgrips and brake controls located on both sides of the stand. For ceiling-mounted systems, manual longitudinal (1), transversal (2), and rotational (3) stand movements remain available. Note: Transversal stand movements (2) are only available for ceiling-mounted systems with the FlexMove option. For floor-mounted systems, only rotational (3) stand movements remain available. The table longitudinal position (4) can be adjusted manually when the table is not tilted (see Figure 1 below).
