Urgent Field Safety Notice O-arm™ 1000 Imaging System

May 2019

Medtronic reference: FA870

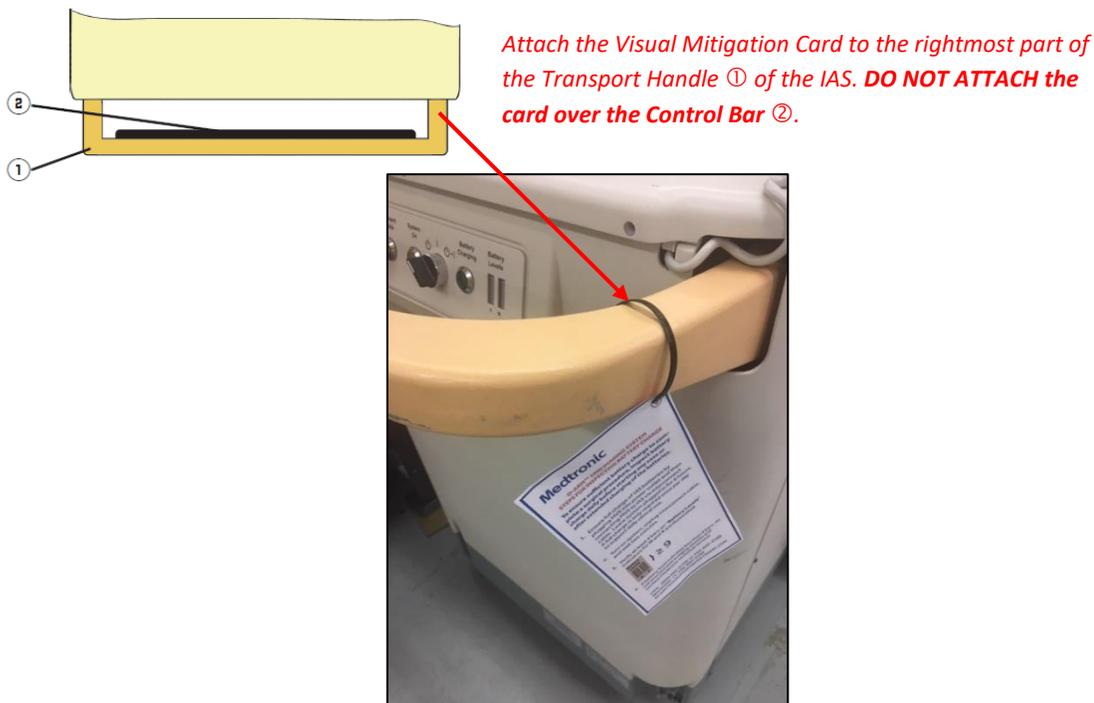
- 1) Attach the Visual Mitigation Card to the IAS of your O-arm™ 1000 Imaging System, as illustrated in the image below, and follow the directions as noted.

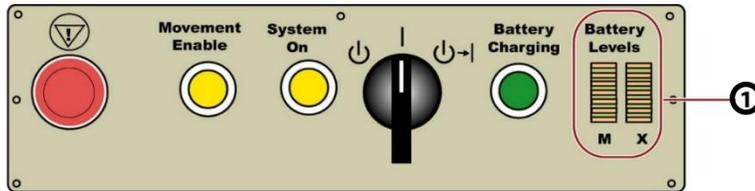
FIGURE 1

Battery Level Indicators: On the IAS Power Control Panel shown in Figure 1, the two columns of yellow LED lights (①) indicate the battery levels for the motion batteries (**M**) and the X-ray batteries (**X**). See “Battery Charge Level Indicators” in the user manual for more information about battery charge levels represented by the scrolling LEDs. See “User Performance Checks” in the user manual to ensure proper operation of the machine.

- While the Image Acquisition System (IAS) is turned on, unplug the interconnect cable and wait two minutes.
- Check the battery charge indicators on the power control panel.
- Verify that the **X** and **M** battery level indicators have at least 9 out of 10 bars illuminated to ensure sufficient battery charge to accomplish the procedure.
- If battery level indicates less than 9 bars, do not proceed with imaging session and contact Medtronic technical service +1-720-890-3160; or via email to RS.NAVTECHSUPPORT@MEDTRONIC.COM.
