Urgent Field Safety Notice
Programmer Software Update
Supporting the Micra™ Transcatheter Pacing System

Model
2090 CareLink™ Programmer
29901 Encore™ Programmer
CareLink Network Application Software 2491

January 2019

Medtronic reference: FA856

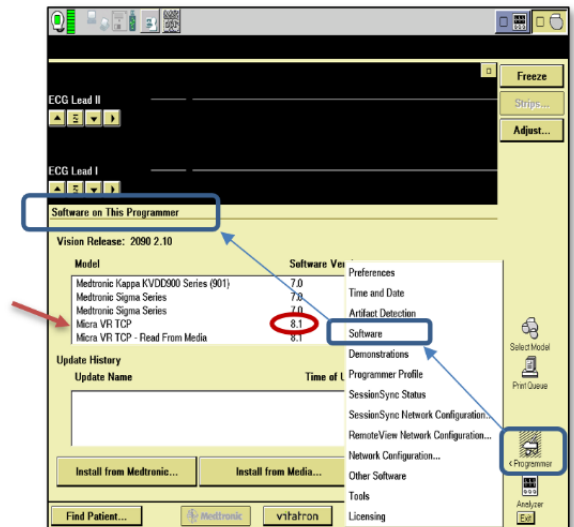
Image 1

- Select Software (see image 1)
- Scroll through the list of available Software Models in the top selection box until you locate the Micra selection
- Verify the Software Micra VR TCP Version is 8.1

Correct software: Micra VR TCP version 8.1 (or higher)

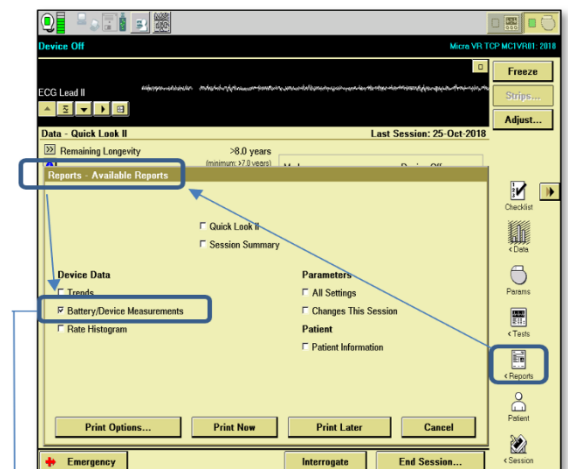
Images 2a and 2b

Any CareLink transmission completed after January 17, 2019 will report the updated remaining longevity estimate. For in-clinic patients who have been interrogated via a programmer, the clinician can view the Battery and Device Measurements Report (Images 2a and 2b) and verify that the Software Application Model ID located in the lower-left corner of the report indicates "SW022 Software Version 8.1".

- Select Reports (see image 2a)
- Select Battery/Device Measurements
- Click Print Now
- Verify the software version printed on the lower left-hand corner is "SW022 Software Version 8.1"
