Urgent Field Safety Notice

SBN-CPS-2019-013

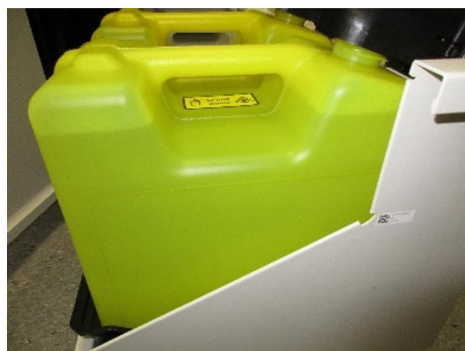
cobas t 511 / t 711: Liquid waste overflow
