Urgent Field Safety Notice

Hugo[™] Robotic-Assisted Surgery (RAS) System ARM CART ASSEMBLY MRASC0002

March 2022

Medtronic Reference: FA1228

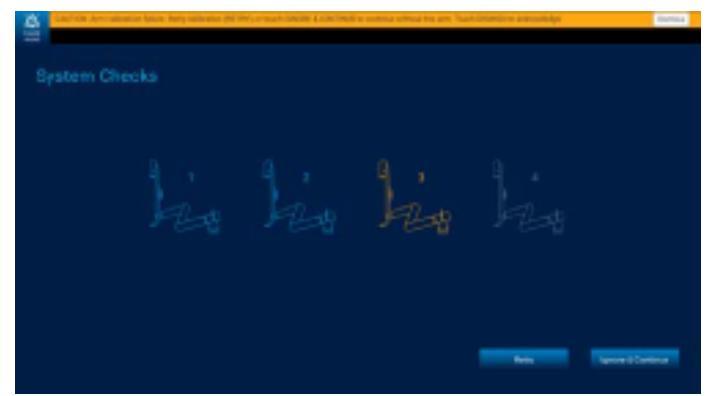
1. If any arms encounter a problem calibrating, the System Checks screen will show the particular arm with the error and provide options to either re-calibrate the arm or ignore the arm and continue.

If an arm has failed calibration, <u>do not</u> select the **Retry** or **Ignore & Continue** button. Instead, restart the arm by performing the following steps:

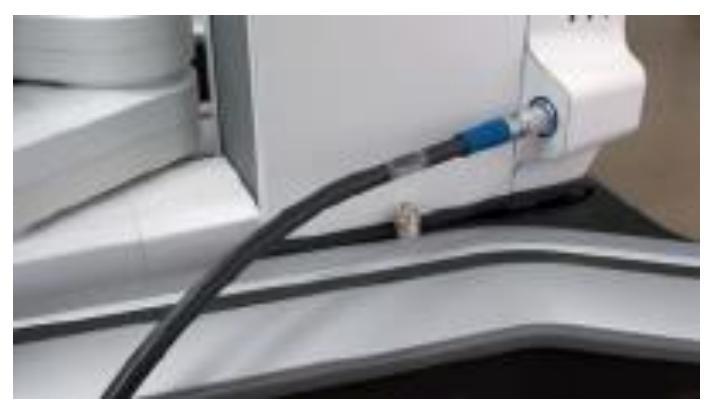
a. Unplug the arm cart data cable from the arm with the error. The arm will shut down and the system will display a message that the arm is no longer connected.

b. Reconnect the arm cart data cable. When the arm completes its startup, the arm cart LEDs will be green and the system will detect the connected arm and display the following message:
