### Philips Image Guided Therapy Corporation URGENT Field Safety Notice Philips Laser System (LAS-100) Error 500

#### JUN-2022

Reference: LAS-100 Error 500, 2022-IGT-IGTD-002

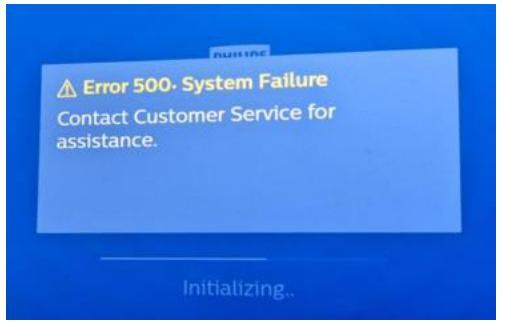
Philips has identified an intermittent mechanical fault with the LAS-100 Philips Laser Systems manufactured prior to 18-MAY-2022. For affected units, on occasion, the system may detect an inoperable hardware component during power up. When this issue occurs, the user will be visually alerted on the system display as "Error 500 – System Failure" (see Figure 1). The user will not be able to proceed until the error is cleared. In this event, a delay in treatment may occur since the device is not able to fully initialize to a ready state. This fault was identified after seven (7) complaints of Error 500 were received. To date, Philips has not received reports of patient or user harm due to this issue.

Figure 1: Example of an Error 500 visual alert

Philips internal testing confirms that 1-3 reboots of the system will temporarily resolve the issue. Philips also recommends the continued use of the Philips Laser System, and to follow the Operator's Manual, as there is no expected harm to the user or patient.

Philips will notify all affected customers and arrange for a Field Service Engineer (FSE) to replace the shutter assembly with an improved shutter assembly free of charge beginning June 2022,. The updated assembly improves the Philips Laser System's performance and integrity.

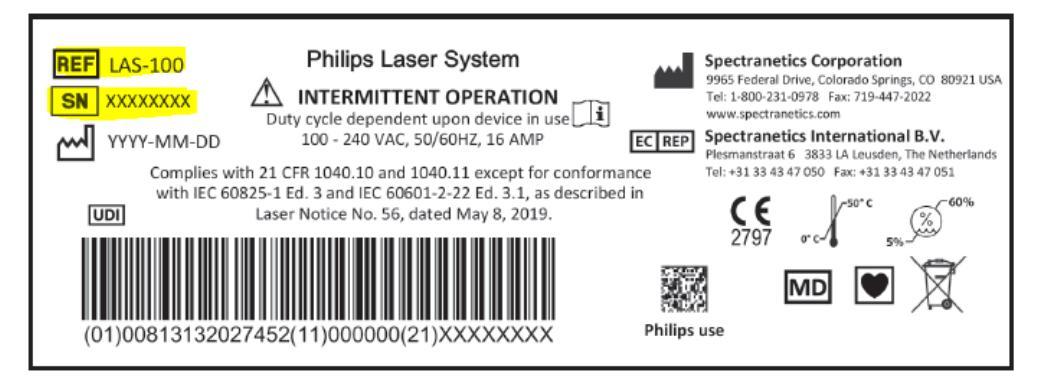
Only the Philips Laser Systems (PLS), model number LAS-100 with the serial number range of 100000 to 100104 are affected. The model and serial number of the PLS are printed on the primary label on the back of the device as shown below.
