RA2013-083: URGENT FIELD SAFETY NOTICE

Description: Triathlon Tibial Alignment Ankle Clamp EM (Instrument)

Catalog #: 6541-2-609

RA2013-08 Product Bulletin Triathlon Tibial Alignment Ankle Clamp

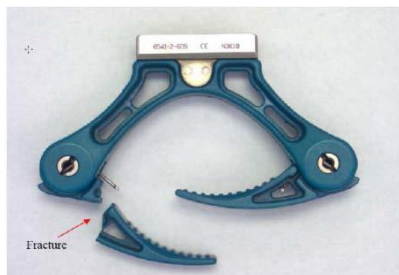
Figure 1

Field Safety Corrective Action Instructions: In the event of a fracture of the ankle clamp portion of the tibial alignment assembly at the flipper (figure 1) or at the yolk (figure 2), the instrument will still function as intended.

The process will remain the same as defined in the surgical protocol (ref. LSPK47 Rev5). Assemble the Tibial Alignment Ankle Clamp to the Tibial Alignment Distal Assembly EM. In case of a compromised Ankle Clamp, firmly hold the Tibial Alignment Distal Assembly EM and press up to/against the Tibia while maintaining alignment. In accordance with the Triathlon Surgical Protocol, flexion / extension alignment is correct when the long axis of the Tibial Resection Assembly parallels the mid-coronal plane of the tibia. Varus / Valgus alignment is similarly assessed per the established methods. (Figure 3)

With a compromised ankle assembly, the surgeon would need to ensure the desired alignment is maintained by holding the assembly in place rather than relying on the stabilization of the ankle assembly. The tibial resection guide would then be pinned in place and the surgeon should proceed with the procedure per the protocol.
