Urgent Field Safety Notice

Fisher & Paykel Healthcare 400HC212 (Lot 130820) & 400HC214 (Lot 130823)

FPH FSCA Identifier: FA-2013-004
Type of Action: Recall

Field Action Plan: NRV Valve in Spare Elbow Kits

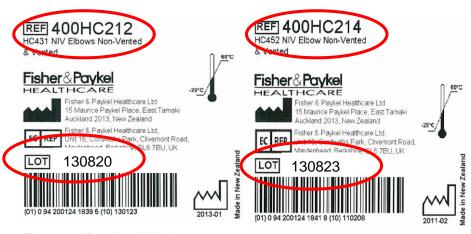
Figure 1: Product labels

Using example labels in Figure 1 below, identify any 400HC212 Lot 130820 and 400HC214 Lot 130823. For any affected product please destroy the vented elbow by disconnecting the 90° elbow from the swivel and immediately disposing of the two parts as per Figure 2 below.

Figure 2: Separated assembly for disposal
