# URGENT FIELD SAFETY NOTICE

No. : FCO-US-14-0002Z  
Control No. : QAU 14-127  
Type of Action : Recall  
December, 2014

## Information about unsealed Sterile Puncture Adapter

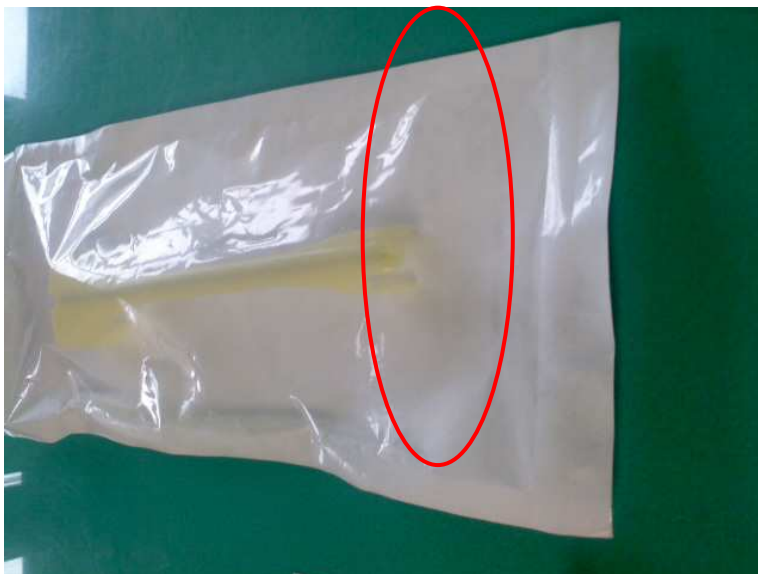
### <Normal PA5V sealed sterilization bag>

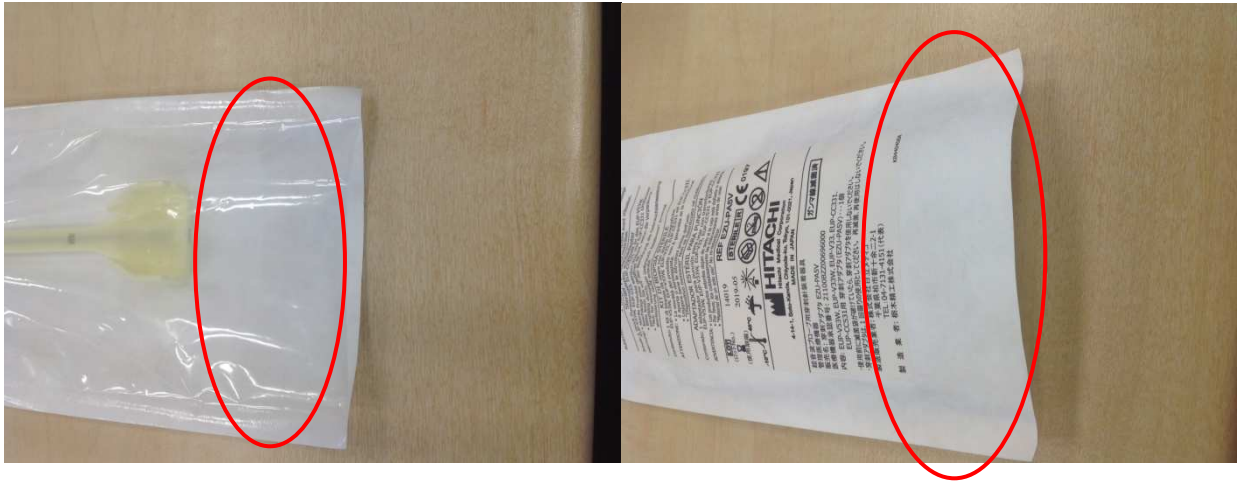
Some products were delivered with incomplete sealing in their individual packaging.

<Failed PA5V unsealed sterilization bag>

- Please confirm if the individual bag is appropriately sealed before breaking a seal.
- If you find the improper sealing condition on the individual bag,
  - 1) do not use the product of improper condition.
  - 2) please contact us as we will exchange the improper product for the new one.

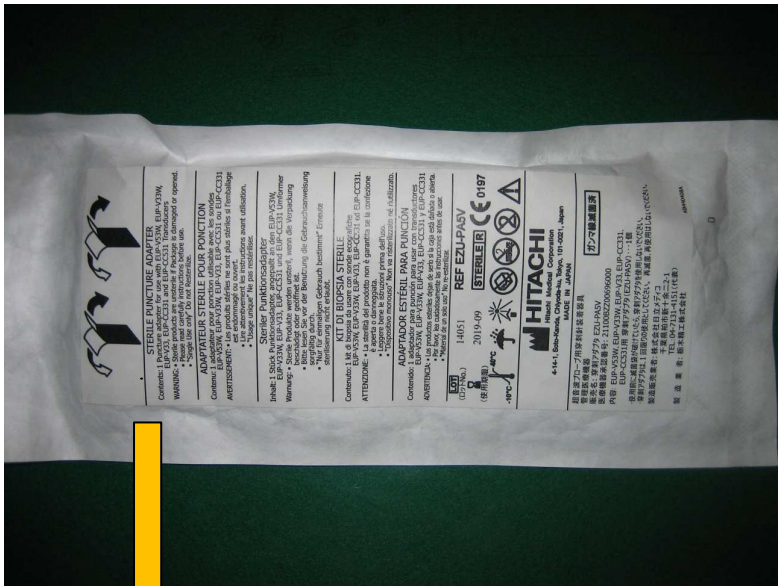
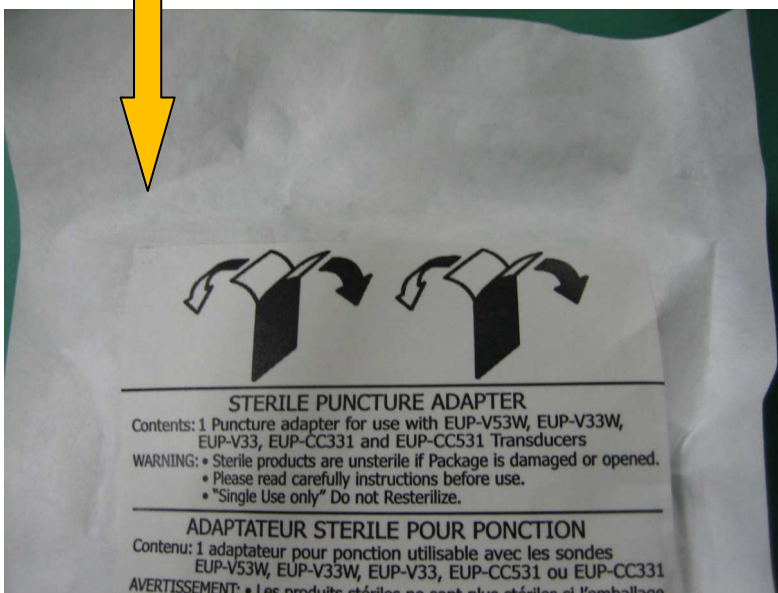
“Sterile products are unsterile if Package is damaged or opened” is indicated on the instruction manual and label of the individual bag of this sterile puncture adapter.

<Warning label : Sterile products are unsterile if Package is damaged or opened >
