Urgent Medical Device - Corrective Action

INNOVA - E4 with 20.000.45 Pressure Chamber Rack

15/12/2014

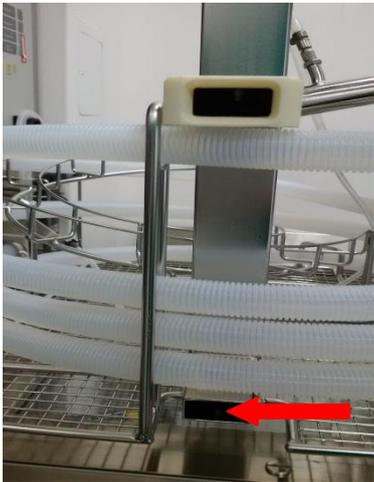
<p><u>Preface and reason for the corrective action:</u></p>	<p>Dear BHT Customer,</p> <p>We are writing to inform you of the corrective action to be taken in relation to a possible error in the performance and effectiveness of the BHT INNOVA – E4 washer-disinfector unit in connection with the 20 000.45 pressure chamber rack accessory.</p> <p>During maintenance work, it was determined by a customer that the fitting pipe between the rack and the water channel for the water supply to the lower level of the washing rack was no longer present. From when and for what reason the fitting pipe was no longer present at the time of the maintenance work has not yet been able to be clarified, an external mechanical influence cannot be ruled out. No further cases could be determined in a precautionary investigation of 11 additional machines at different operators. In its delivery condition, the component is attached in a force-locked manner and is secured additionally by two locking screws that are glued in.</p> <p>The fitting pipe has a double function: it bridges the distance from the rack to the water channel and at the same time, it opens the water channel to the machine as a result.</p>

In connection with the 20000.45 pressure chamber rack accessory
<u>Affected countries</u>	Germany, Poland, Lithuania, Denmark, Finland, The Russian Federation, Canada
<u>Measures that must be taken by the customer/user:</u>	<ol style="list-style-type: none"> 1. Inform the affected users and their service personnel 2. Check the pressure chamber rack for completeness and check the functioning of the water supply. If this fault should have occurred, then the device must not be used any further for treatment until the device has been returned to its original condition. 3. Instruct the users that they have to check the functioning of the water supply between the water channel and the rack for <u>every</u> loading of the machine with the pressure chamber rack in the future. Document this instruction in the machine logbook. 4. We would like to ask you to reply to this letter in accordance with the attachment. 5. Amend your machine documentation with the appendices that we have supplied and add them to your operating instructions and technician's handbook.
