# **Field Safety Notice**

Concerned products: Ceiling Lift Altair, Roomer S and HeliQ

FSCA 30th of June 2016

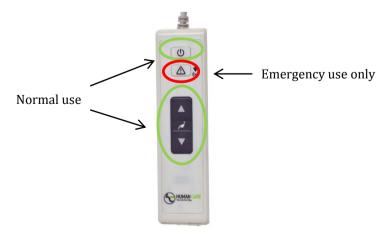
It has come to our attention that some customers use the emergency lowering button in order to lower the lift/hanger bar instead of using the down button on the hand control. As stated in the user manual, the emergency lowering button shall only be used in emergency situations and not under normal conditions.

For safety reasons the emergency lowering function disables other safety functions such as end stop breakers, and belt tension guard switch. When using the emergency lowering button the lift gets down faster which can give unnecessary discomfort to the patient. There is also a risk for the belt roll in the lift to turn in the opposite direction, which can damage the product.

There have been reported incidents where the emergency lowering function been broken after extended misuse and caused a constant motion of the belt resulting in a fully retracted belt with a permanent damaged to the hoist. If this would occur with a patient attached to the lift the emergency break should always be used.

In order to prolong the lifetime of the product and also to increase comfort for the patient, the emergency lowering button should never be used, except in a true emergency situation.

- Secure that staff have proper education and understand how to use the hand control.
- Secure that the staff understand the consequences that could happen when systematically using the emergency lowering function in daily operation.
- Confirm back to Human Care by signing this document that this message has been received and understood.
