## Urgent Field Safety Notice

### Spinous Process Clamp Tall and Short (Model 9734715 and 9734716) Double Spinous Process Clamp Tall and Short (Model 9734723 and 9734724) Important Device Information

Medtronic reference: FA774

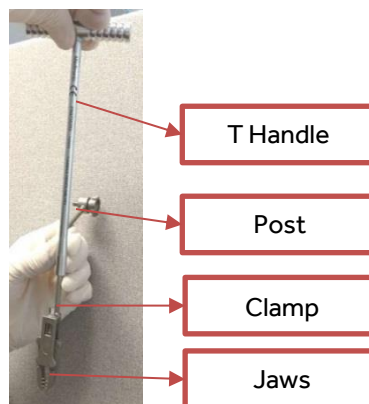
Figure 1

1. Hold the spine clamp by the post with the jaws pointing down. See Figure 1.
2. Use the T-handle to turn the clamp screw.

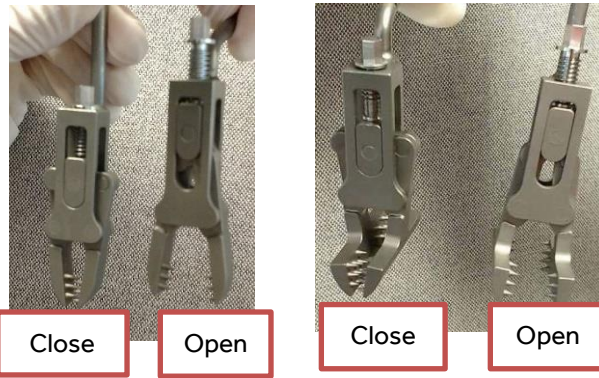
3. By turning T-handle clockwise, **close** the jaws fully to baseline position of the jaws.
4. Then open the jaws of the clamp by turning The T-handle counter-clockwise. See Figure 2a and 2b.

Figure 2a: Single Spine Clamp

Figure 2b: Double Spine Clamp

**If the jaws open, the clamp is functioning properly and can be used in the procedure.**

Note: Do not continue to turn T-handle if resistance is met as this may cause the captive washer to break off the device.

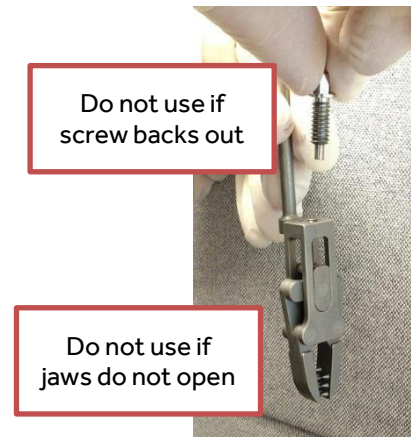
Medtronic has become aware of instances where Spine Clamps have been damaged when forced open beyond its intended limits during use and will subsequently not open once attached to a patient's spinous process. When the Spine Clamp is forced open beyond its intended limits, a component (captive washer) may break off. The washer could then be inadvertently left behind in a patient's body if the breakage occurs during the procedure. If the washer is missing from the device, the spine clamp cannot be re-opened after placement on the spinous process. Medtronic has received 6 reports where unintended removal of spinous process occurred when attempting to detach the Spine Clamp. The unintended removal of spinous process can lead to damage of adjacent vertebra and cause premature degradation.

- The jaws remain closed when attempting to open the clamp.
- The clamp screw backs out of the clamp. See Figure 3

Figure 3: damaged spine clamp

**DO NOT USE THE CLAMP if either of the following occurs:**

Please follow the instructions above for all spine clamps at your facility immediately upon receipt of this letter. Medtronic has implemented a design mitigation in new Spine Clamps to prevent the user from inadvertently damaging the device by opening beyond its intended limits. The revised spine clamps are available. If you identify a damaged spine clamp due to this issue, please quarantine the device and contact your Medtronic Representative.
