URGENT – FIELD SAFETY NOTICE
Concerto & Basic shower trolley

Date:	2019- MMM-DD
Product Issue:	Concerto & Basic shower trolley – Potential unintentional drop of safety side panel
Affected Product:	<ul style="list-style-type: none"> ✓ Concerto & Basic shower trolleys manufactured between November 2018 and June 2019; Serial number ranges: P0512263 to P0551621 ✓ Concerto & Basic shower trolleys fitted with the affected spare parts (safety catch) part no. 8451622, 8546608, S8533571-031, S8533572-031, S8533570-031 S8542201-014, S8523559-031, 100-805-03, 100-806-03 during service between 2019-Nov-27 and 2019-Jun-14
Affected Serial No.:	Attachment A
Resolution:	Safety catches replacement in order to ensure the device is operating safely
Field Safety Notice:	FSN-POZ-002-2019
Pages:	3 & Customer Response Form

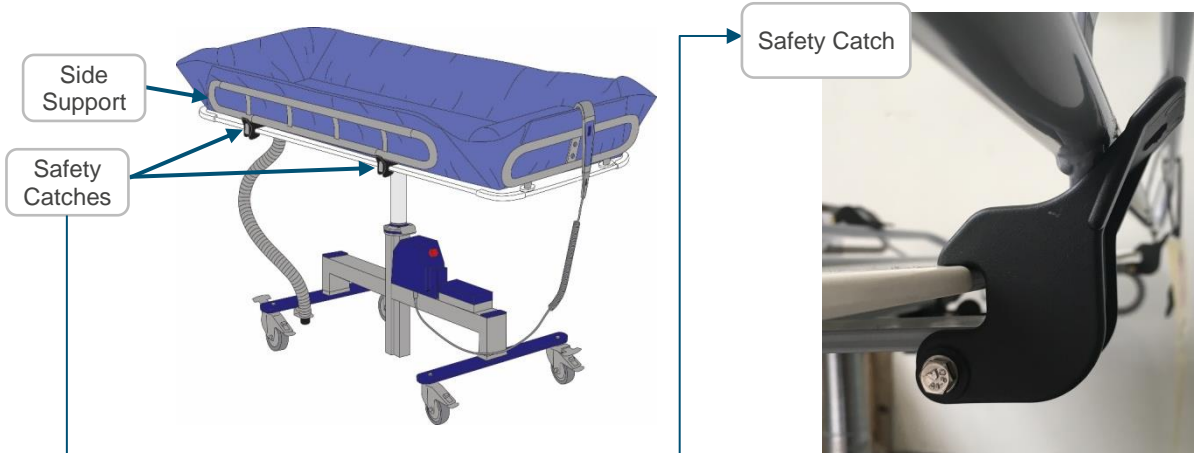
Image 1

Each Concerto & Basic shower trolley is equipped with two Side Supports, one on each side of the shower trolley (Image 1). Each side support is secured by two (2) Safety Catches (Image 2) which are used to fold down the supports as well as secure the support in the raised position.

Image 2

Arjo has become aware that any of the 4 Safety Catch(es) may exhibit a mechanical failure (break in one of the arms of Safety Catch), which in certain circumstances may contribute to the Side Support unintentionally opening and may lead to a potential risk of patient fall, leading to possible injuries to patient and/or caregiver.
