## Field Safety Notice

### Information on intraoperative handling of the MRP-TITAN® screw M6

Reference	R-20200217-3
Affected products	
Article Number	Designation
60901-04	Screw M6 short
60901-07	Screw M6 long
97021-55-1	Allen Key SW 5 Ball Head

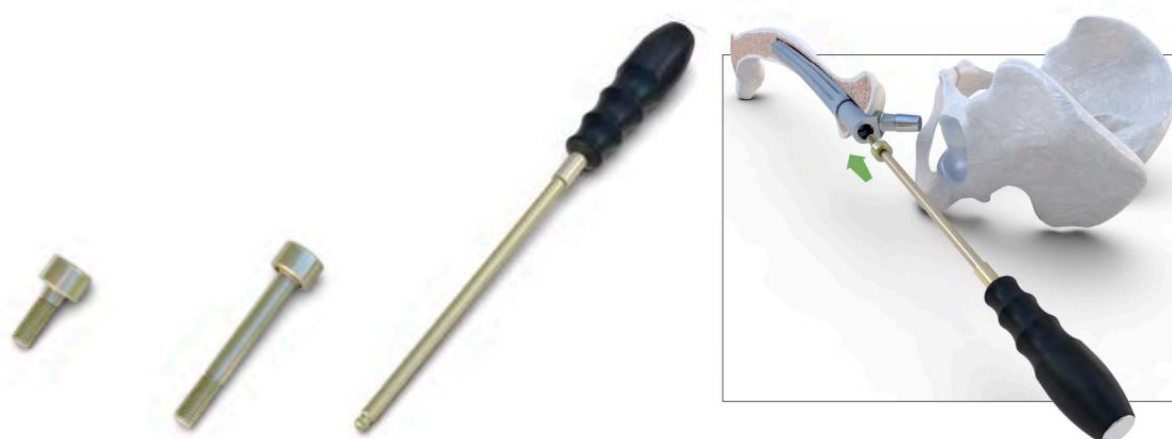
New test results indicate dried blood on the thread of the M6 screw or in the internal thread of the anchoring stem may cause screw breaks. The dried blood in the thread blocks the screw before it is fully seated. When securing with a tightening torque of 25 Nm, the screw M6 may break.

Also, PETER BREHM GmbH has been informed the mandated gold-colored Allen key SW5 ball head (item no.: 97021-55-1) is not always used intraoperatively. By not using the gold-colored Allen key SW5 ball head (item no.: 97021-55-1) transversal forces can occur, whereby the screw M6 will not completely screwed in axially and can block it. During the following securing with a tightening torque of 25 Nm, the blocking can lead to a breakage of the screw M6 in worst case.

- Before screwing in the connecting rod, make sure that it is free of soil to avoid contamination of the internal thread in the anchoring stem.
- It is also important to ensure that the screw M6 itself is free of contamination before it is screwed in.
- Before screwing in the screw M6, ensure the internal thread of the anchoring stem is still free of contamination. Therefore, the internal thread must be thoroughly rinsed with at least 100 ml saline solution (NaCl 0.9%) using a syringe. Make certain the thread is not damaged by the flushing.

- The screw M6 must **always** be attached with the gold-colored Allen key SW5 ball head (item no.: 97021 55-1) and screwed in as far as possible with little effort. Only then secure the screw M6 in conjunction with the torque limiter.
