## URGENT FIELD SAFETY NOTICE

GEHC Ref# 32081

RE: **Mounting issue for Lullaby™ Resus Plus/Prime dovetail mounts onto Lullaby™ Warmer side rails**

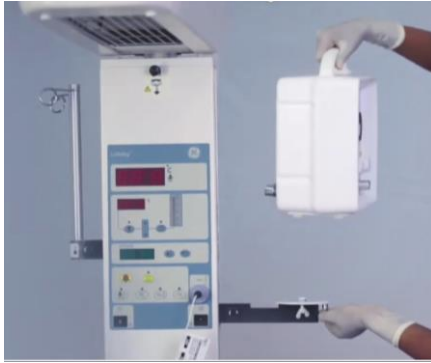
1. Lock wheels of the Lullaby™ Warmer.
2. Disconnect Air/Oxygen hoses of the Lullaby™ Resus Plus/Prime device (If they are connected).
3. Disconnect the Lullaby™ Resus Plus/Prime from the dovetail mount accessory. See Fig 2 for details.

Fig 2. Disconnect and remove Lullaby™ Resus Plus/Prime from the dovetail mount

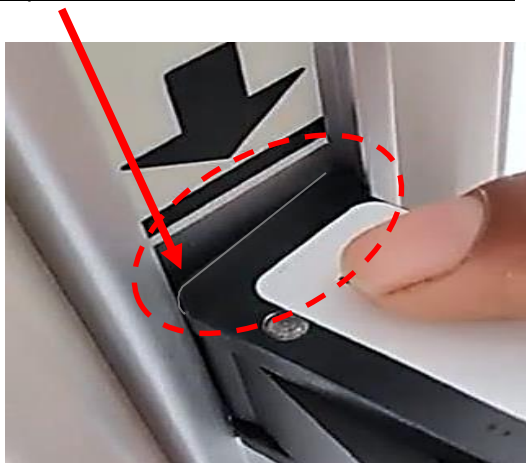
Gap between the dovetail mount and the rail

**Fig 3 Incorrect installation due to defective dovetail mount accessory (gap or opening presence)**

5. If you find the incorrect installation as shown in the Fig 3, disconnect the dovetail mount, remove the mount from use, and destroy it.
6. If the Fig 4 conditions are observed, ensure that dovetail mount is firmly fixed by tightening the mounting screws. In the event the dovetail mount needs to be installed on a different Lullaby™ Warmer device, ensure to recheck for proper installation of the dovetail mount.

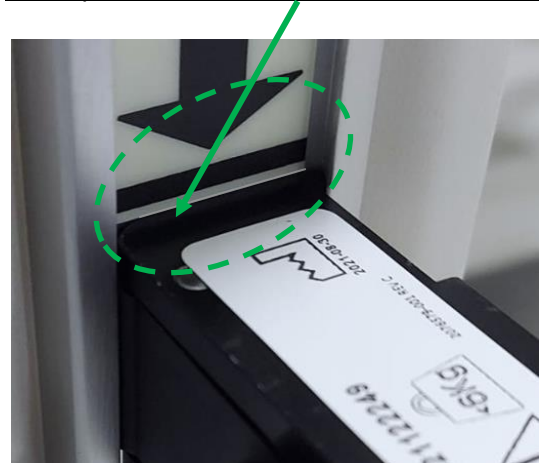
4. Check for the proper installation of the dovetail mount with the dovetail rail. See Fig 4 for the correct installation condition.

No Gap between the dovetail mount and the rail

**Fig 4 Correct installation (full contact with no gap) of the dovetail mount with the dovetail rail**
