URGENT – FIELD SAFETY NOTICE

Arjo Sara Plus lift – Risk of ignition

Affected Product: Sara Plus floor lifts

Field Safety Notice: FSN-POZ-001-2022

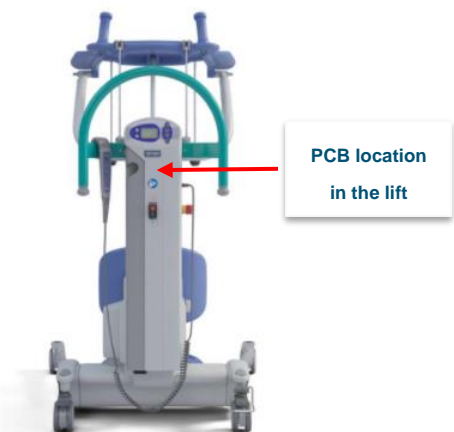
PCB location
in the lift

Our sales and service records indicate that you may be in possession of one or more Sara Plus lift equipped with a PCB (Printed Circuit Board) that is prone to damage during the product use. The PCB is an electronic part located inside the lift underneath the cover, as shown below.

It has been found that internal damage of the affected HMX1350-1 PCB may lead to overheating of the part and excessive heat emission. The heat generated is unlikely to evolve into a flame that could damage the PCB cover or, in the worst case, cause its ignition.

We are contacting you to arrange a visit of an Arjo service engineer in order to complete the Sara Plus correction with a service kit developed by the manufacturer at your facility, with no need to return the product to us.

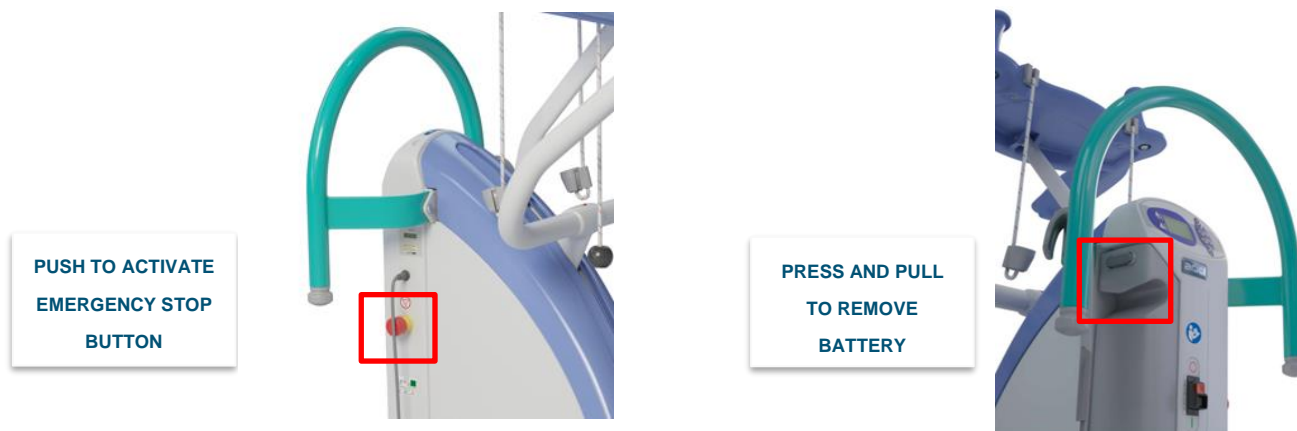
The ignition can be preceded by white smoke coming out of the lift. The emitted smoke is not harmful and unlikely to result in any health consequences. **However, as soon as you notice the smoke, stop using your Sara Plus lift immediately– push Emergency Stop Button and remove the battery from battery socket to prevent from any further failure (please refer to an image below). Next, contact Arjo at [insert local phone number] or via email at [insert email address] for further assistance.** The smoke will phase out completely by itself after less than 3 minutes.
