**Subject: URGENT - FIELD SAFETY NOTICE – Integra – Codman® CereLink® ICP Monitor, Model: 826820: ICP Monitor Reading Default – Field Safety Notice**

826820 - Codman® CereLink® ICP Monitor  
All serial numbers ranging from CLK2111003 to CLK2215542

**Table 1: Product and Distribution Information**

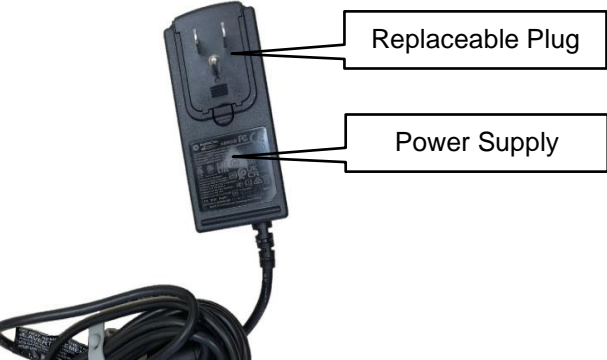
5.	<p>The CereLink® Power Supply comes with the CereLink® Monitor. <b>The connection between the CereLink Power Supply and the outlet could come in two configurations: 1) a power cord or 2) a replaceable plug. Please ensure both are properly attached (see below).</b></p> <div style="display: flex; justify-content: space-around;"> <div style="text-align: center;"> <p>Power Cord Configuration</p>   <p>Power Cord</p> <p>Power Cord to Power Supply Connection Point</p> <p>Power Supply</p> </div> <div style="text-align: center;"> <p>Replaceable Plug Configuration</p>

<p>Replaceable Plug</p> <p>Power Supply</p> </div> </div>
