FIELD SAFETY NOTICE
for End-Customers using
Hamilton Medical Ventilators HAMILTON-C1/T1/MR1
Reference #: FSCA 2023-07-03

Hamilton Medical AG is recalling certain of the ventilators' HAMILTON-C1/T1/MR1 control boards after receiving reports that the device may interrupt ventilation due to a faulty capacitor. Hamilton Medical AG received nine complaints involving ventilation interruption, while neither serious injuries nor deaths related to this issue were reported.

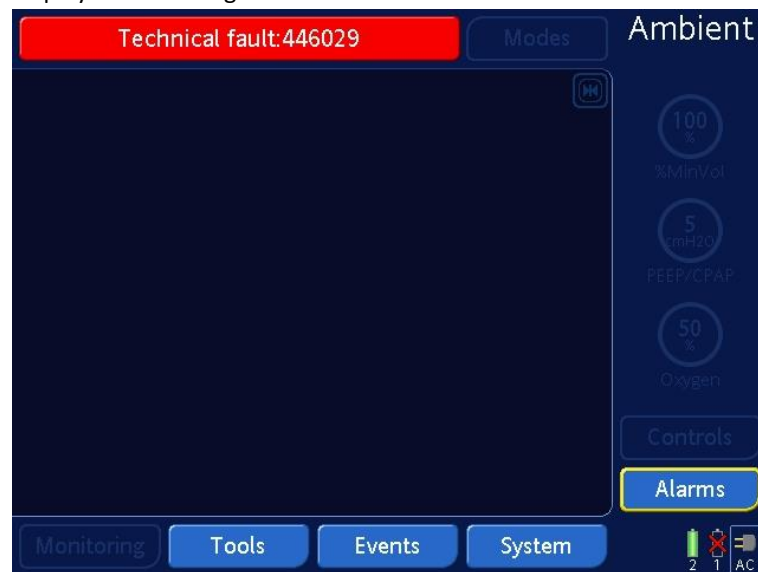
A degrading capacitor on the control board might leak electrolyte onto the control board, causing a short circuit on the board and/or the capacitor might lose its function. The primary function of this capacitor is to provide energy to store “Realtime Clock” information in case of total loss of power (external AC supply and battery) for example during storage.

As a result of the short circuit, affected HAMILTON-C1/T1/MR1 ventilators might switch to the “Ambient State”.

During the “Ambient State” the ventilator will alarm audibly and visually and display the following on the screen:

Figure 1: The display indicates “Ambient State”, and a red message with a Technical Fault number (example, a different Technical Fault number might be displayed)

Required user actions if failure occurs: In such a case, perform the following actions steps:

1. Provide alternative ventilation immediately.
2. You must switch off ventilator power to exit the “Ambient State”.
3. Once patient safety is ensured, it is required to have the ventilator serviced.
