Field Safety Notice

**Achieva 1.5T, Achieva 1.5T Conversion, Ingenia 1.5T CX, Intera 1.5T,
Intera 1.5T Power/Pulsar, SmartPath to dStream for 1.5T**

Gradient Coil component failure may act as a heat source with potential to produce smoke and/or fire.

October 23, 2023

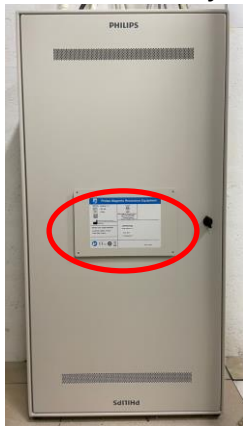
Figure 2: Front door of GMDU

- 3.1. Enter the Technical Room
- 3.2. Locate the general Mains Distribution Unit (gMDU)
- 3.3. The system label is located on the front door of the gMDU (see figure 2)
- 3.4. Locate the serial number on the system identification label (see figure 3)

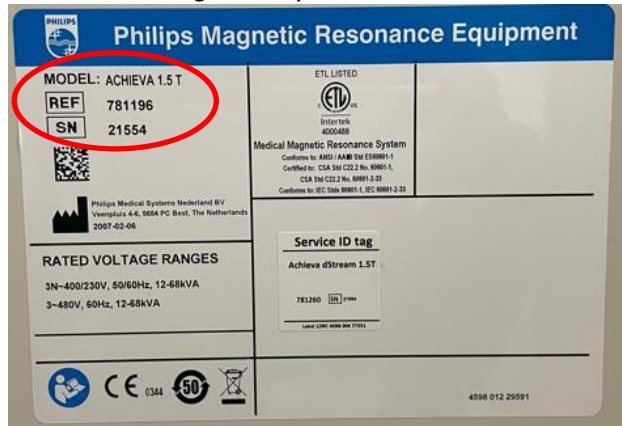
Figure 3: system label

The affected 1.5T MR Systems including product number (REF), name (Model) and serial number (SN) are listed in Appendix A. Figure 1 illustrates the location of the product number (REF), name (Model), and serial number (SN).

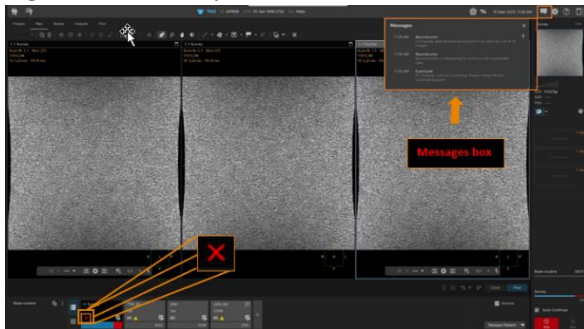
Figure 5. UI example SW Version R11.

- 4.3. When scan aborts occur the symbol is shown and applicable messages are presented in the message box (see Figure 5 and Figure 6 examples)
 - 4.3.1. Check the status of the error messages in the User Interface (UI) screen. Click to expand the message box in case previous messages are hidden, see orange box in Figure 5 and Figure 6 below. If possible, correct the issue that is relevant to the error shown, and continue scanning, for example:
 - “RF door must be closed while performing scan. Scan aborted.”
 - “Patient support is moved while scanning, scan stopped.”
 - “Coil A (or B) failure, coil disconnected?”.

- 4.3.2. If, after a scan abort, one of the following conditions occur five times in a row stop scanning immediately and contact Philips Service to describe the problem:
 - If there is no error message in the message box
 - If the error message meaning is not clear
- 4.3.3. If the error message “Gradient amplifier Rack Fault” is received two times in a row, or if the error message “Gradient amplifier Rack Fault” is preceded or followed by an aborted scan with no message, then stop scanning immediately and contact Philips Service to describe the problem.
- 4.3.4. If you encounter any of these conditions described in 4.3.2 or 4.3.3 do not attempt any additional/further scans, including without limitation do not attempt any phantom scanning until your system has been checked and released by a Philips Service representative.

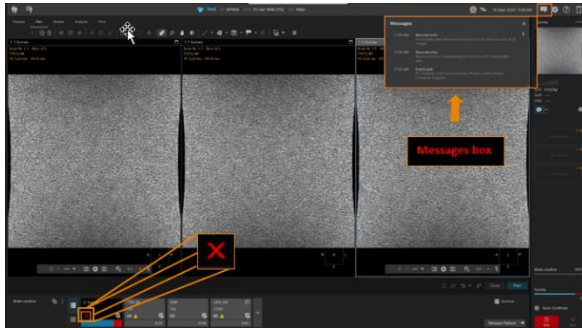
Figure 5. UI example SW Version R11.

- 4.3. When scan aborts occur the symbol is shown and applicable messages are presented in the message box (see Figure 5 and Figure 6 examples)
 - 4.3.1. Check the status of the error messages in the User Interface (UI) screen. Click to expand the message box in case previous messages are hidden, see orange box in Figure 5 and Figure 6 below. If possible, correct the issue that is relevant to the error shown and continue scanning, for example:
 - “RF door must be closed while performing scan. Scan aborted.”
 - “Patient support is moved while scanning, scan stopped.”
 - “Coil A (or B) failure, coil disconnected?”.

- 4.3.2. If one of the following conditions occur five times in a row stop scanning immediately and contact Philips Service to describe the problem:
 - If there is no error message in the message box
 - If the error message meaning is not clear
- 4.3.3. If the “Gradient amplifier Rack Fault” error message is received two times, or if the error message “Gradient amplifier Rack Fault” is received followed by an aborted scan with no message, then stop scanning immediately and contact Philips Service to describe the problem.
- 4.3.4. If you encounter any of these conditions described in 4.3.2 or 4.3.3 do not attempt any additional/further scans, including without limitation do not attempt any phantom scanning until your system has been checked and released by a Philips Service representative.
