Olympus reference: QIL FY24-EMEA-29-FY24-EMEA-14 White Tape

URGENT FIELD SAFETY NOTICE

Product Return to Olympus Repair Center for additional Inspection

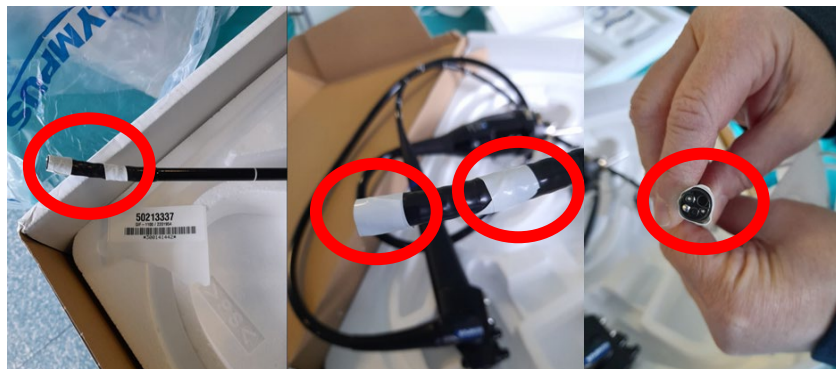
Olympus recently received complaints indicating that the insertion tube of a repaired endoscope was wrapped with white tape.

Wrong – White Tape

This white tape is used during the repair process to protect sensitive parts of the endoscope from damage, (scratches and dents). It is to be removed during final

inspection prior to being returned to the customer for patient use. The endoscope is not intended to be used on a patient with this white service tape attached.

If not removed, the white tape could potentially damage the mucosal tissue and lead to bleeding. Additionally the tape could fall off during examination, fall into the patient's digestive tract and potentially be retained. If the tape slips off during insertion into the oral cavity it may cause aspiration, respiratory distress, and asphyxia. Reprocessing of an endoscope with the white tape attached might lead to insufficient disinfection with the potential for risk of contamination and subsequent patient infections.

You may have detected the white tape in the meantime and removed it. In an abundance of caution, Olympus recommends the return of your product for an additional inspection to ensure that your endoscope is meeting our repair and inspection specifications and standards.

1. Carefully read the content of this Field Safety Notice.
2. Inspect your inventory to identify the device(s) **XXXXXXXX** with serial number(s) **XXXXXXXX**.
3. If you find the product wrapped with white tape at the distal end or had found and already removed it, segregate the device and cease usage with immediate effect.
3. Contact your Olympus customer service representative by **[Regional contact]**. Olympus will issue a Return Material Authorization to return any affected product at no charge.

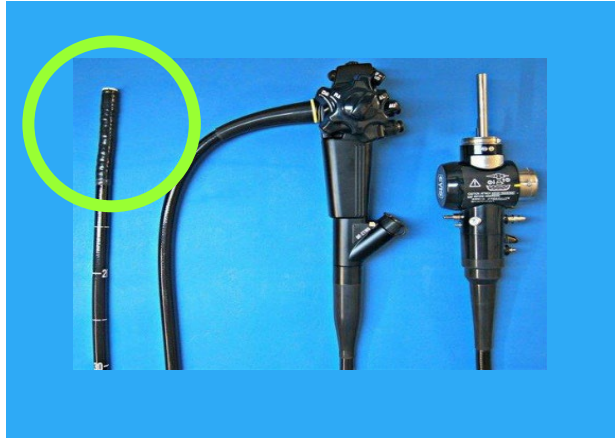
Correct – no tape
