**Field Safety Notice**

**Height Adjustable (HA) FlexTrak Trolley**  
 Potential falling hazard resulting from HA FlexTrak Trolley oil leakage

May 03, 2024

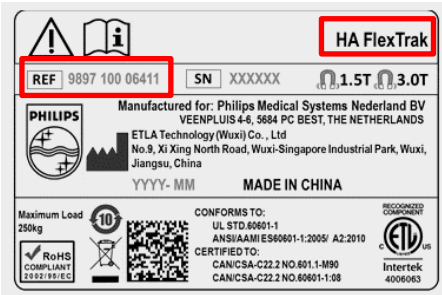
Impacted products can be identified by the product name and product number (REF) as shown in Figure 1.

Example Product Label	Product Name	Product Number (REF)
