URGENT Field Safety Notice

Philips MR system breast coils
Potential for harm while using a breast coil

October 31, 2024

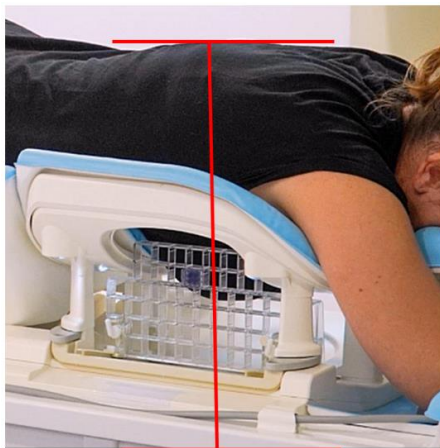
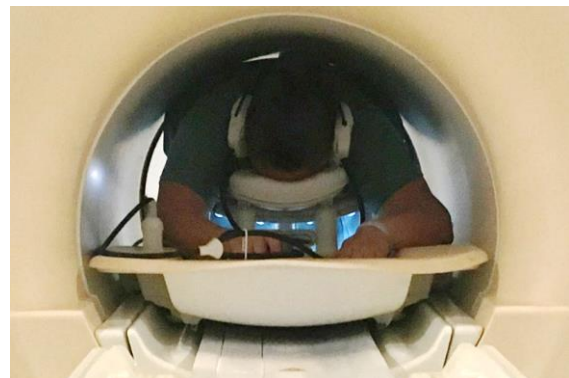
Philips has identified an issue with patient set up while using the MR system breast coil where, if the cross-section of the prone patient, breast coil, and patient table exceeds the internal diameter of the magnet bore, the patient may be compressed between the breast coil and top of the magnet bore potentially resulting in harm to the patient (see Image 1).

Image 1: (Left) *Cross-section: combined measurement of patient height, breast coil, and table. Must not exceed the internal diameter of the magnet bore.* (Right) *Incorrect patient set up: patient is touching/pressed against the side of the bore.*

- A. Customers can continue using the identified systems in accordance with the intended use.
- B. When using the system:
 - Follow section *PRECAUTIONS, CAUTIONS & WARNINGS* in the Instructions For Use (IFU) provided with your coil:
 - i. *When using breast coils if the patient's back touches the bore and stops the table movement, do not manually force the table to iso center, this could cause injury to the patient.*
 - ii. *When positioning the coil on the table and the patient in the coil, always check that the coil and/or the patient will not hit the bore when moving the table, this could result in patient injury. Refer to the system Instructions for Use for positioning instructions.*
 - Follow section *Positioning>Safety* in the IFU: *Ensure clearance between body parts and the bore wall.*

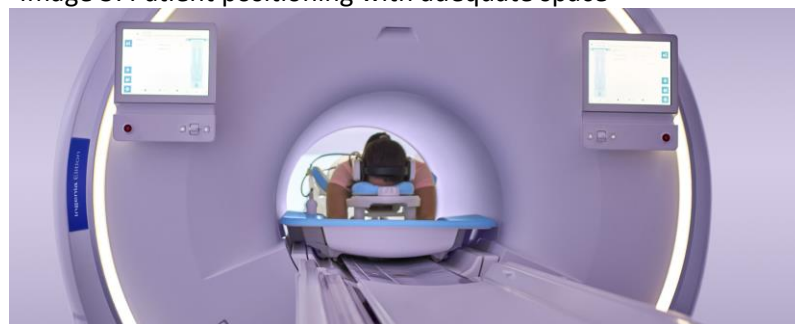
Image 3: Patient positioning with adequate space
