Date: 18 JUL 2025

**Urgent Field Safety Notice (FSN)**  
**XtremeCT**

<b>1. Field Safety Notice (FSN) information</b>	
FSN Reference number	FSN-C-25-07
FSN Date	18 JUL 2025
Product/ Device name	XtremeCT
<b>Serial Number</b>

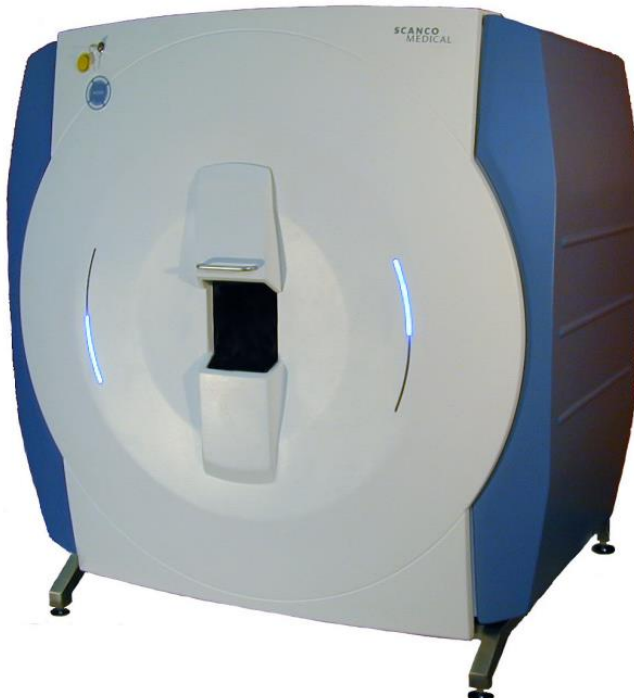
CT-system (HR-pQCT)

2. Reason for Field Safety Corrective Action (FSCA)	
2.	<p>1. Description of the product problem</p> <p>A vertically mounted metal plate inside the bore may fall down due to component degeneration.</p>

3. Type of Action to mitigate the risk	
3.	<p>1. Action To Be Taken by the User</p> <p> <input checked="" type="checkbox"/> Identify Device  <input checked="" type="checkbox"/> Quarantine Device  <input type="checkbox"/> Return Device  <input type="checkbox"/> Destroy Device  <input type="checkbox"/> On-site device modification / inspection  <input type="checkbox"/> Follow patient management recommendation  <input checked="" type="checkbox"/> Take note of amendment / reinforcement of Instructions For Use (IFU)  <input type="checkbox"/> Other  <input type="checkbox"/> None </p> <p>The device must not be used until the corrective action has been performed by the manufacturer.</p>

3.	<b>4. Action Being Taken by the Manufacturer</b>  <input type="checkbox"/> Product Removal <input checked="" type="checkbox"/> On-site device modification/inspection <input type="checkbox"/> Software upgrade <input checked="" type="checkbox"/> IFU or labelling change <input type="checkbox"/> Other <input type="checkbox"/> None  <p>The manufacturer SCANCO Medical AG will improve the mounting system of the metal plate. The IFU has been amended to include an updated maintenance plan. After 5 years the mounting system of the metal plate must be serviced.</p>
